# **City of Karratha**

## **Dampier Stormwater Management Study**

### **Report**

June 2015

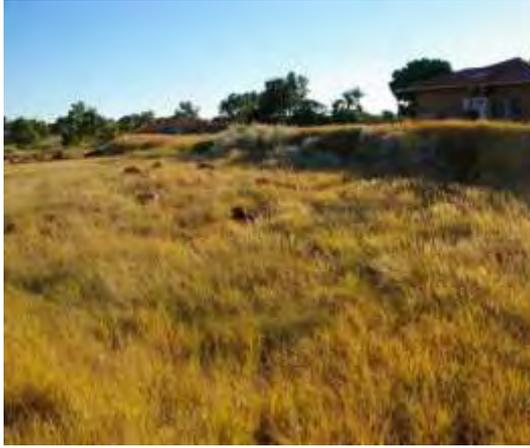
**Photo 1 Typical fill of house pads**

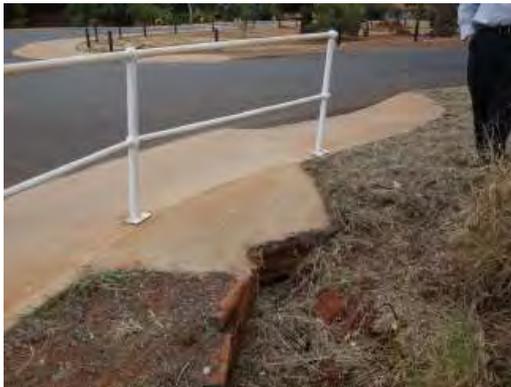
The missing details of culverts have been noted on the attached plan mark-up within Appendix A. During the site investigation the condition of a number of existing culverts were noted and recorded as shown in Photos 9 and 10, further photos are available in Appendix C. In general the culvert condition was poor with significant debris namely leaf litter, sediment and gross pollutants found at the upstream end of the culverts resulting in blockage and reduced culvert capacity.

**Photo 9 Blocked Culvert**

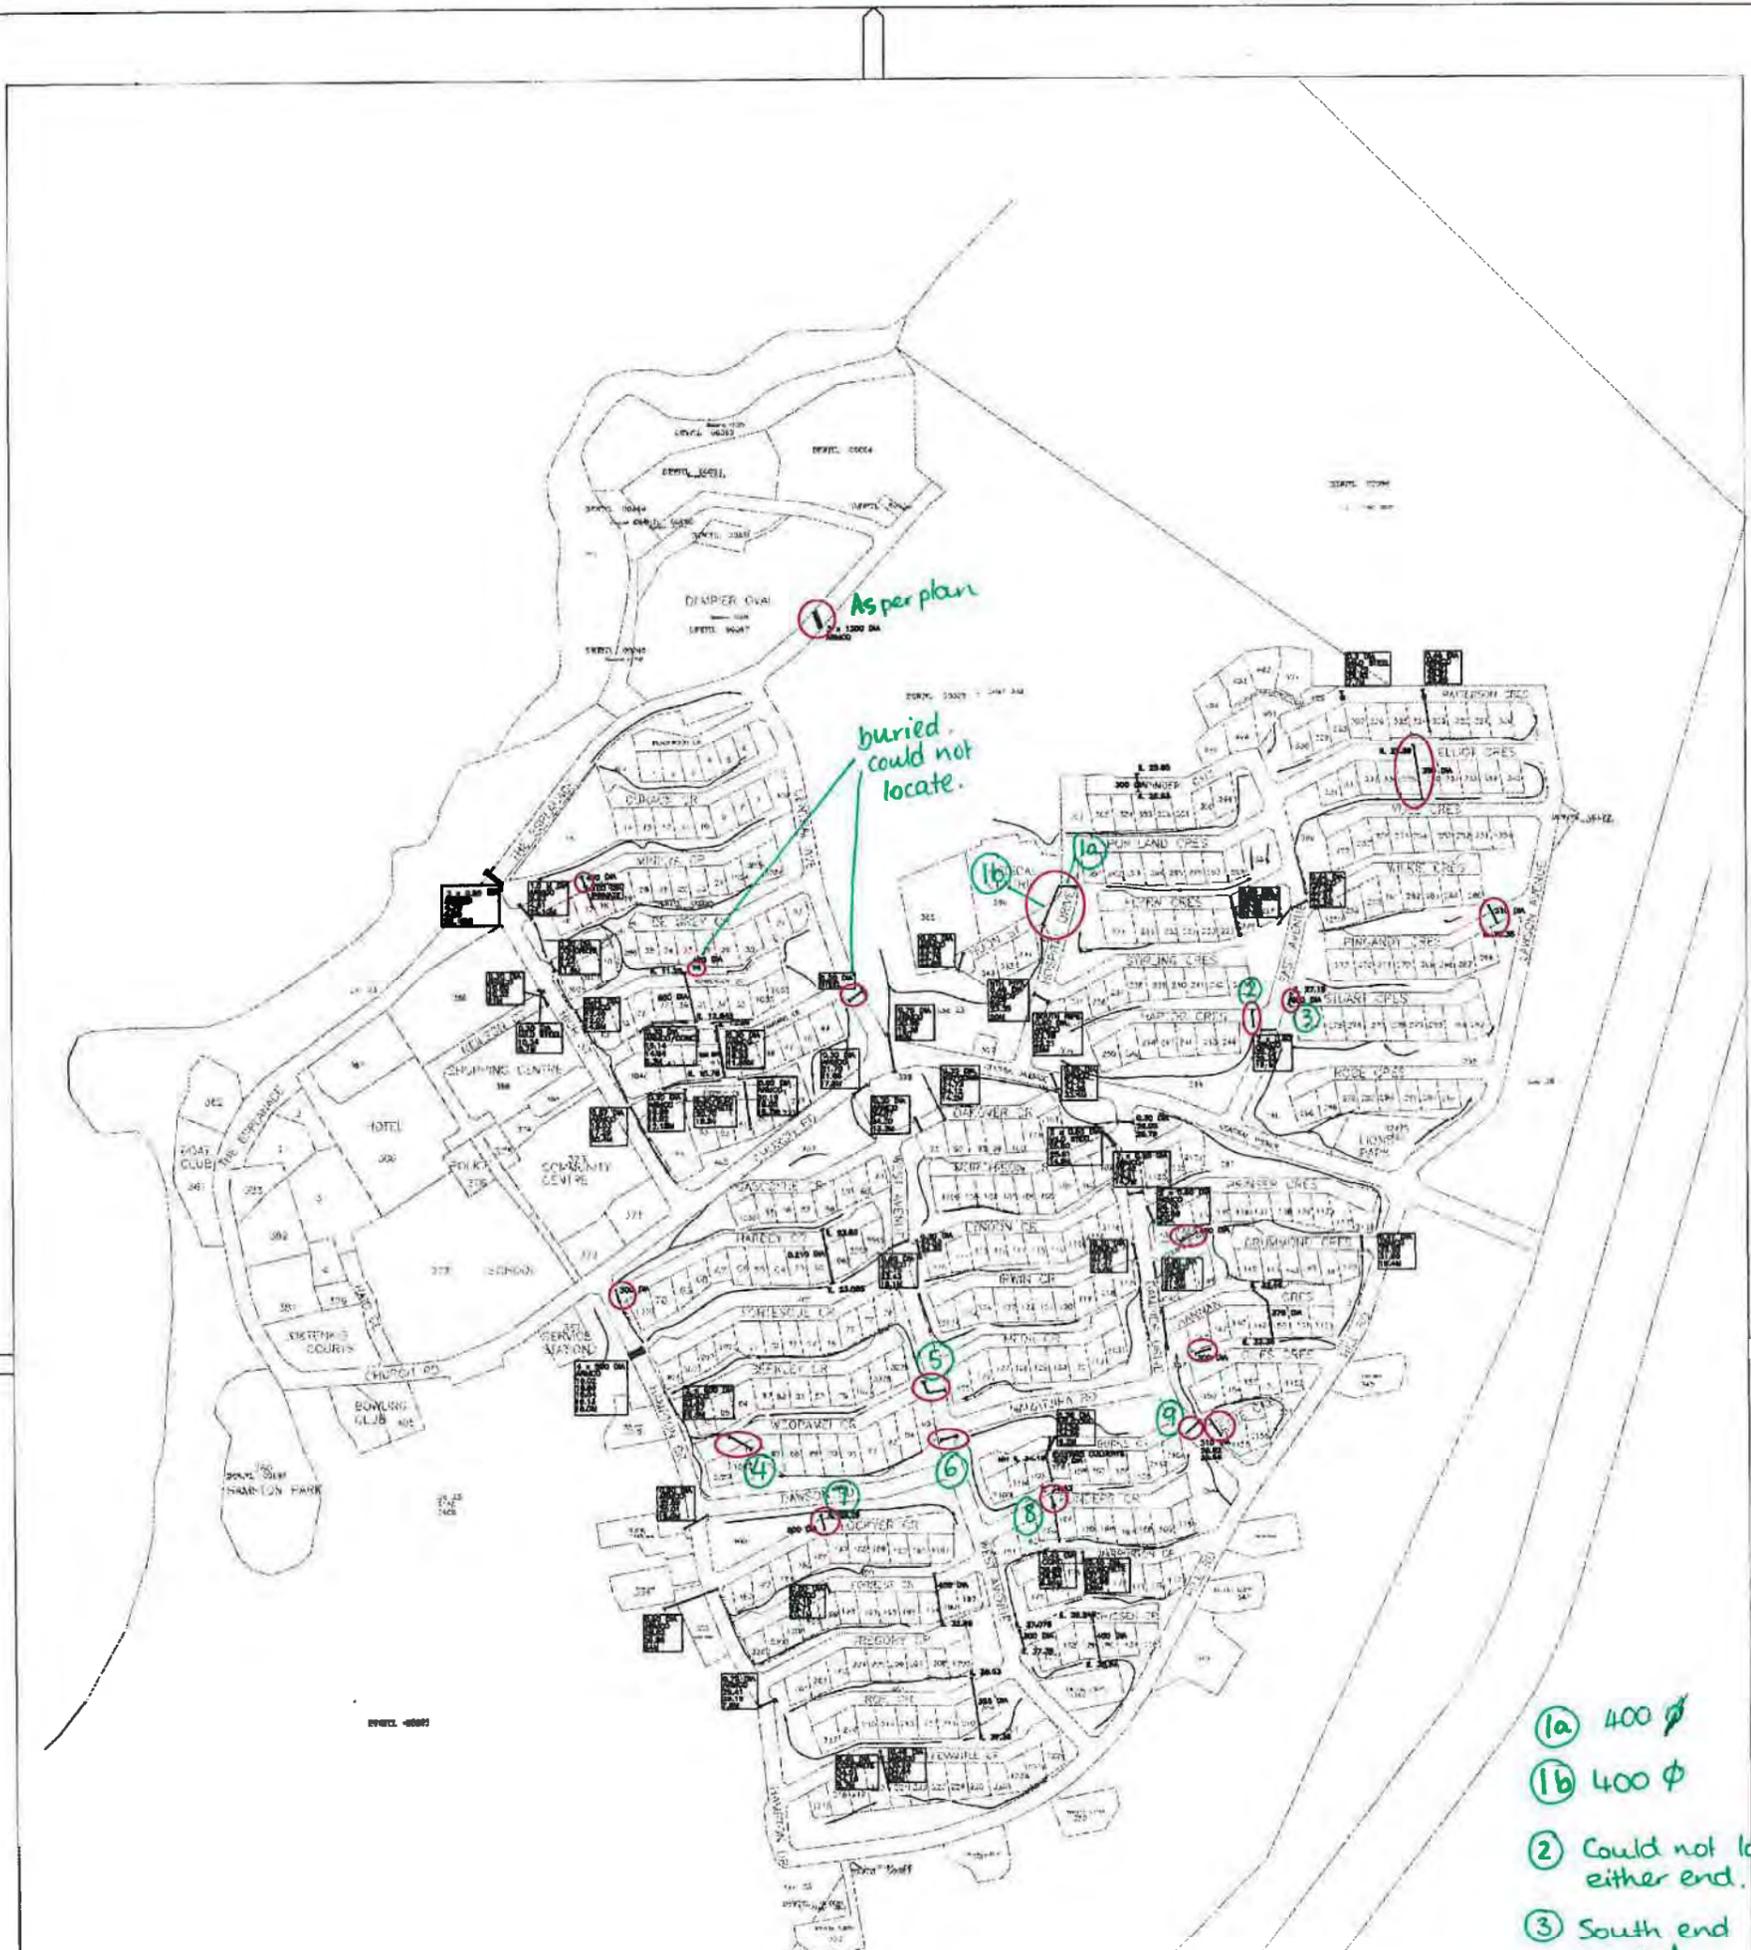
- ①a 400φ
  - ①b 400φ
  - ② Could not locate either end.
  - ③ South end buried.
  - ④ 300φ North end blocked
  - ⑤ Wooramel: 600 wide box outlet, 400φ inlet.  
West ave: 400φ inlet.
  - ⑥ 600φ
  - ⑦ As per plan
  - ⑧ Flinders: 600φ
  - ⑨ Burke: 400φ  
Eyre: couldn't locate
- All others as per diameter on plan.

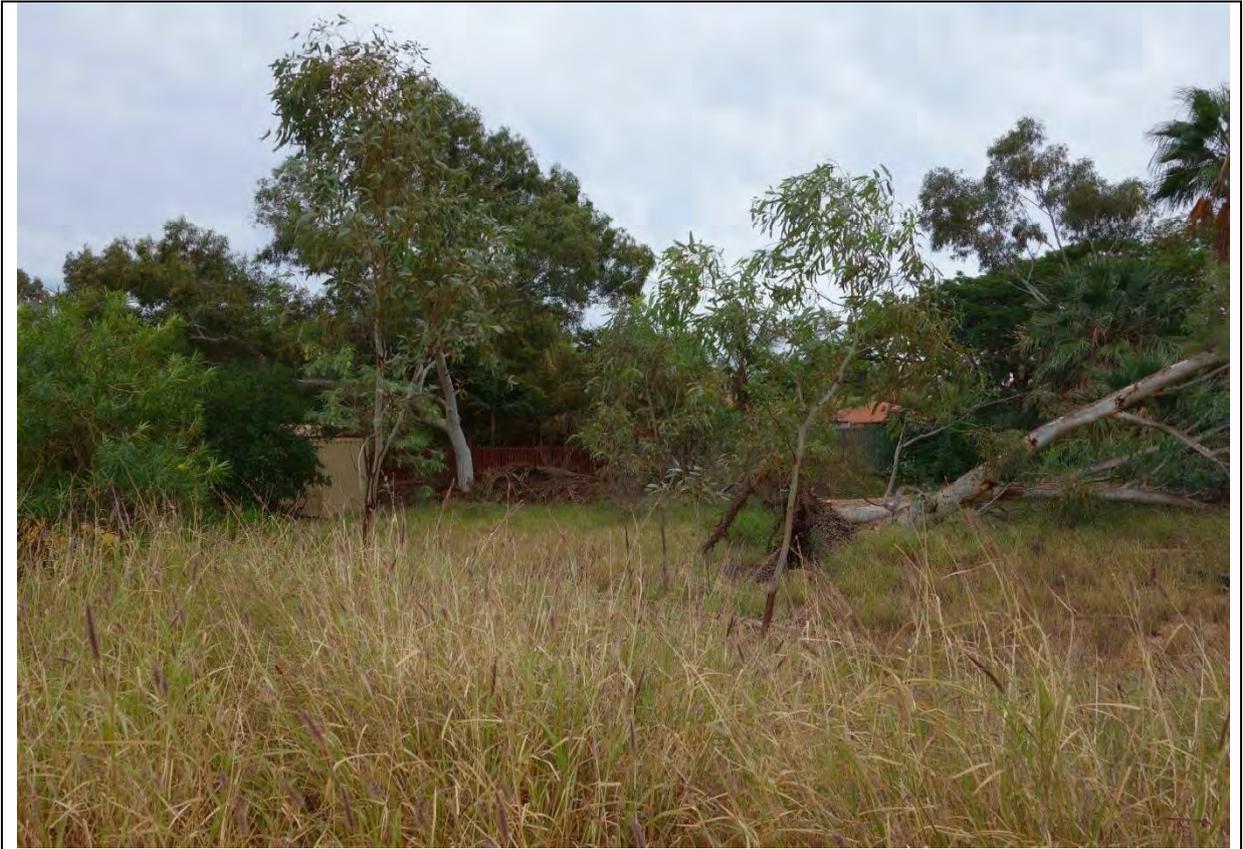
Photo ref. DSC04570

A large tree at the back of Lot 68 Hardey Crescent has fallen over and may cause a disruption in the drainage path (photo DSC04570 in Appendix C). City of Karratha noted that this tree should be removed.

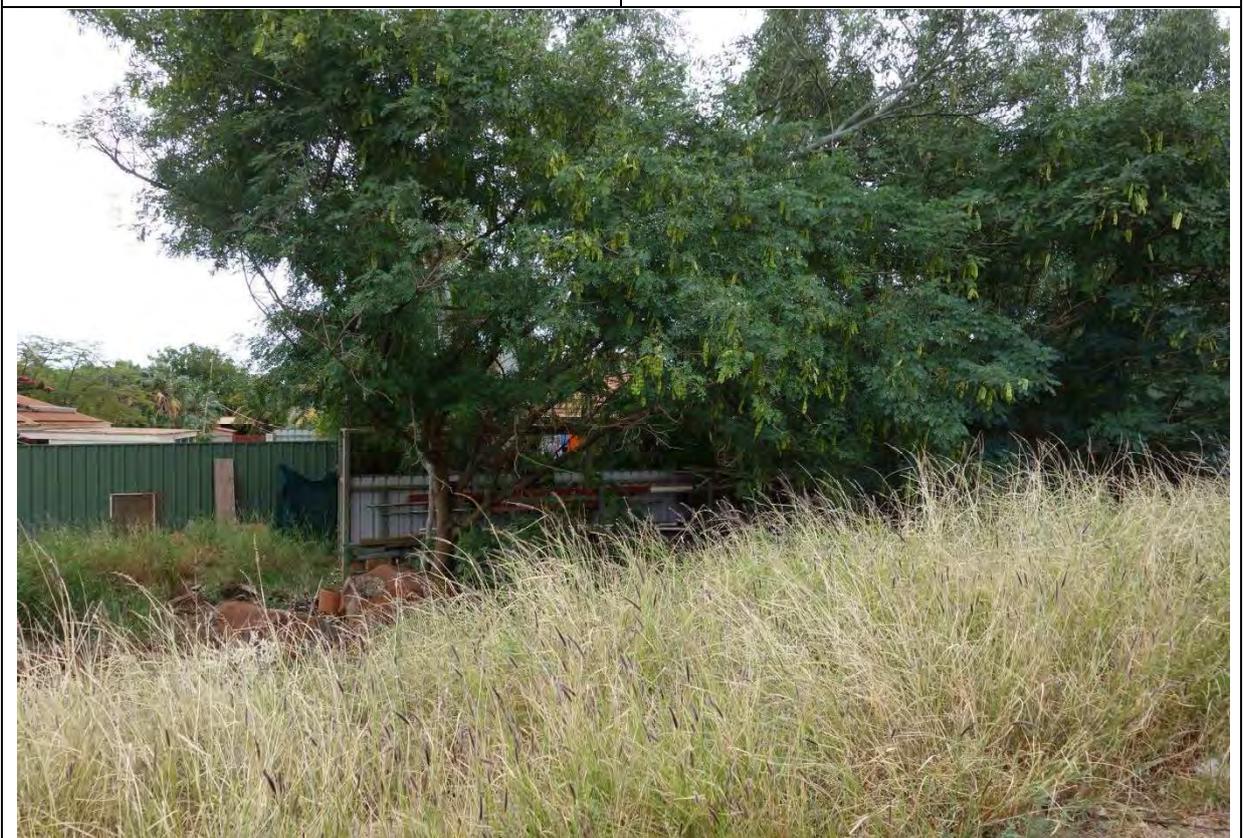
Photo ref. DSC04555

The location of the fence and shed on Lot 2,071 Fortesque Crescent should be confirmed by the City of Karratha (photo DSC04555 in Appendix C); the impact on the elevation grid was noted and incorporated into the final surface.

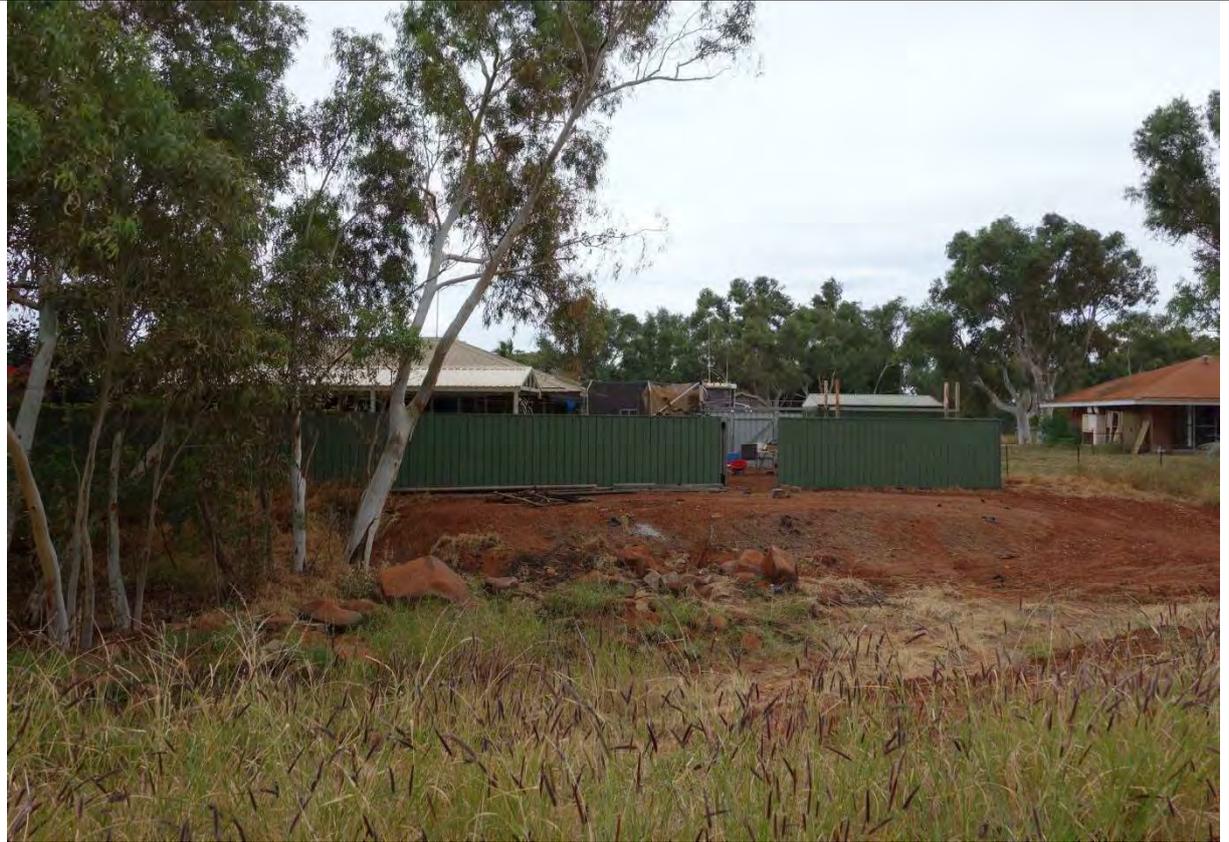
Photo ref. DSC04556

The fill at the back of Lot 1,071 Fortesque Crescent (photo DSC04556 in Appendix C) is within the drainage reserve; the impact on the elevation grid was noted and incorporated into the final surface. City of Karratha noted that this material should be removed.

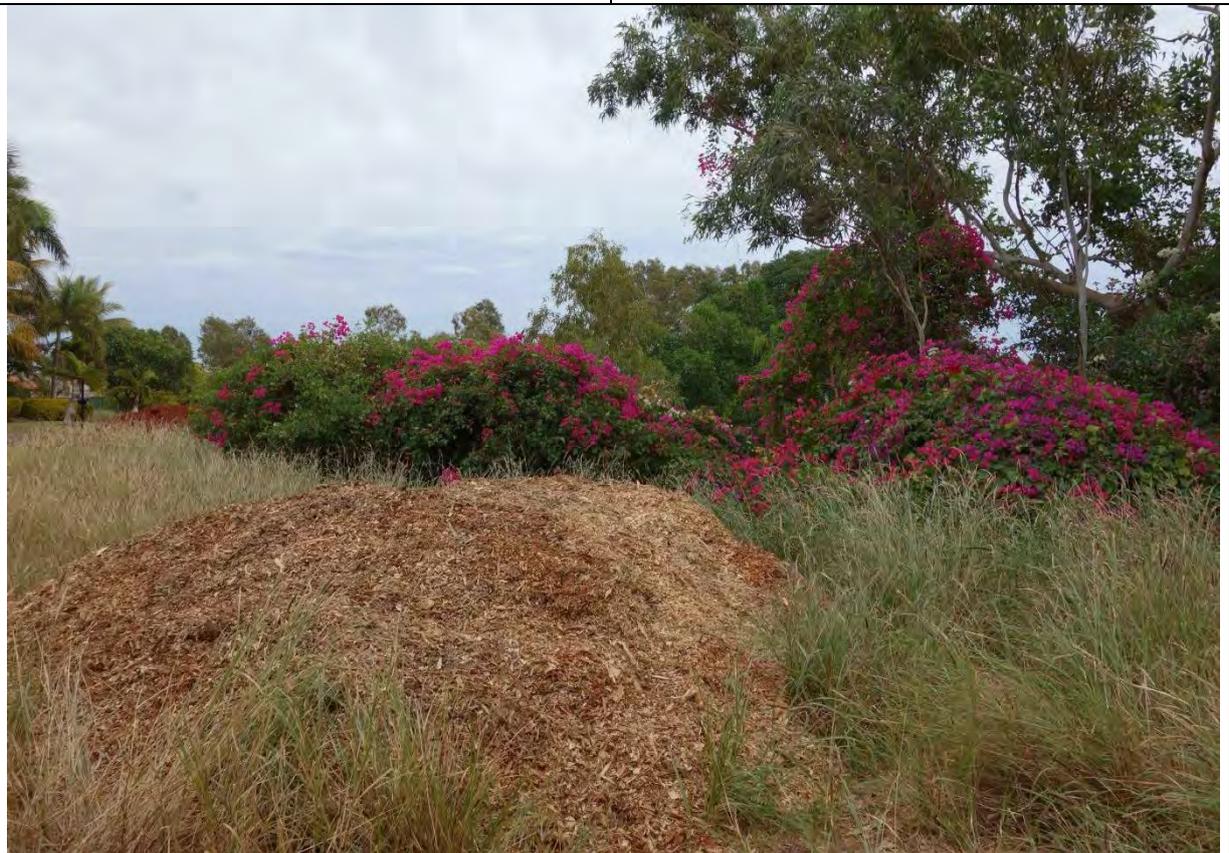
Photo ref. DSC04560

The fill at the back of Lot 1,079 Berkeley Crescent (photo DSC04560 in Appendix C) is located within the property boundary. The impact on the elevation grid and flow paths were noted and incorporated into the final surface. The City of Karratha noted that this material should be removed. The City of Karratha is to check the scope of works stated for Lot 82 Berkley Crescent. The scope should read "Remove fence and relocate to within the property boundary". The elevation model does not include an obstruction at this location noting its removal.

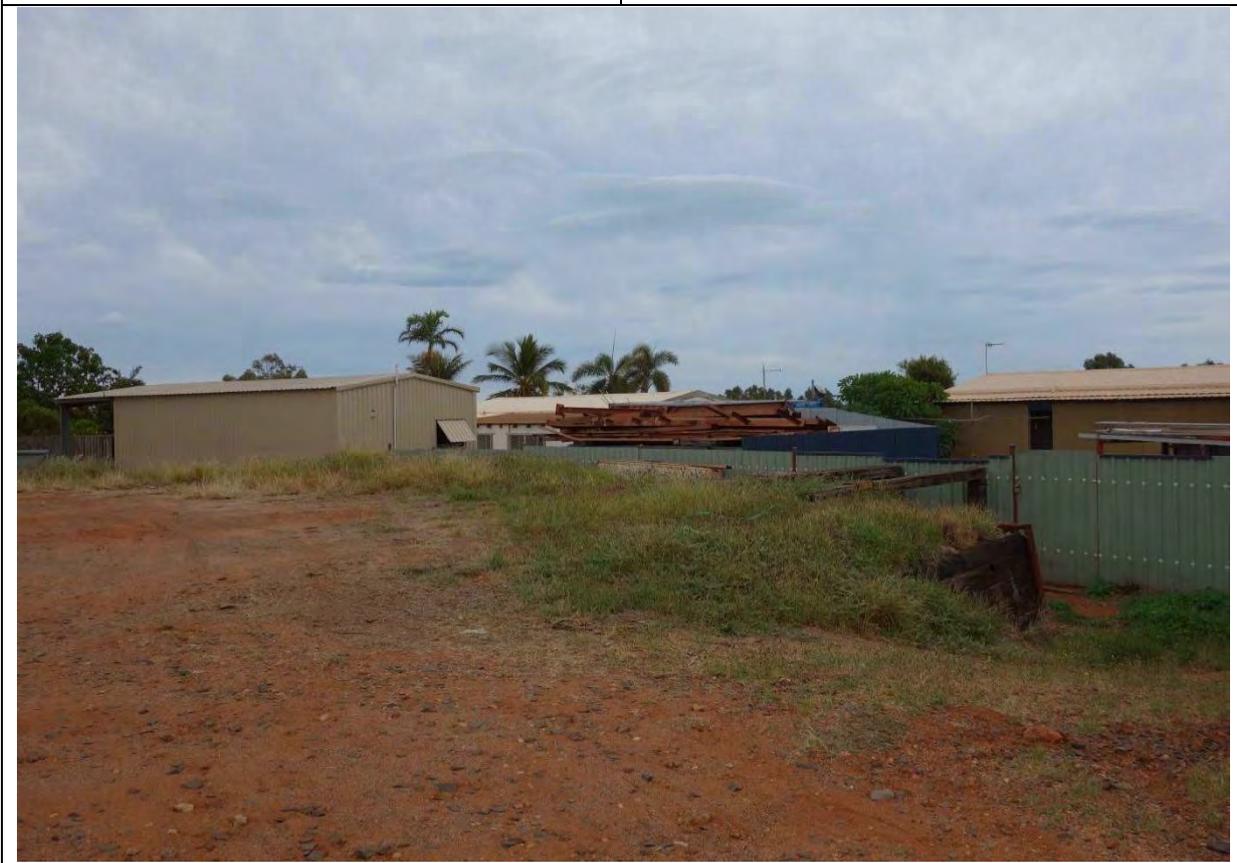
Photo ref. DSC04572

The retaining wall and fill at the back of Lot 185 Lockyer Crescent should be checked by the City of Karratha to confirm they are within the property boundary (photo DSC04572 in Appendix C). The impact on the elevation grid and flowpaths were noted and incorporated into the final surface. The cubby house erected at the back of Lot 186 Lockyer Crescent should be checked by City or Karratha to confirm it is within the property boundary (photos DSC0473 and DSC0474 in Appendix C). The impact on the elevation grid and flow paths were noted and incorporated into the final surface.

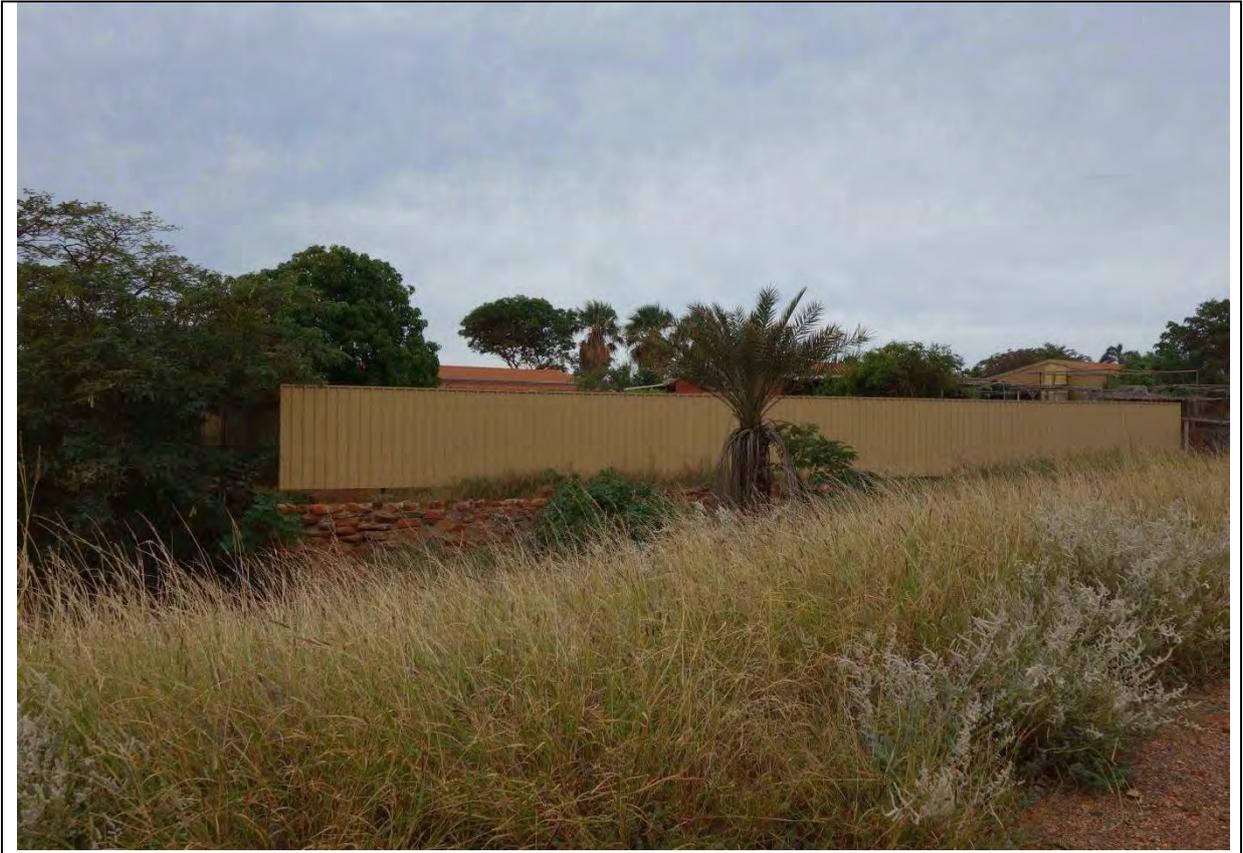
Photo ref. DSC04582

There is a new fence and rock retaining wall at the back of Lot 195 Forrest Crescent that should be checked by City of Karratha to ensure they are within the property boundary (photo DSC04582 in Appendix C). The impact on the elevation grid and flow paths were noted and incorporated into the final surface.
