DEVELOPMENT PLAN REPORT

**Lot 504 Nickol, Karratha
(Former Tambrey Primary School Site)**

Part I – Statutory Provisions

Report No: 3789

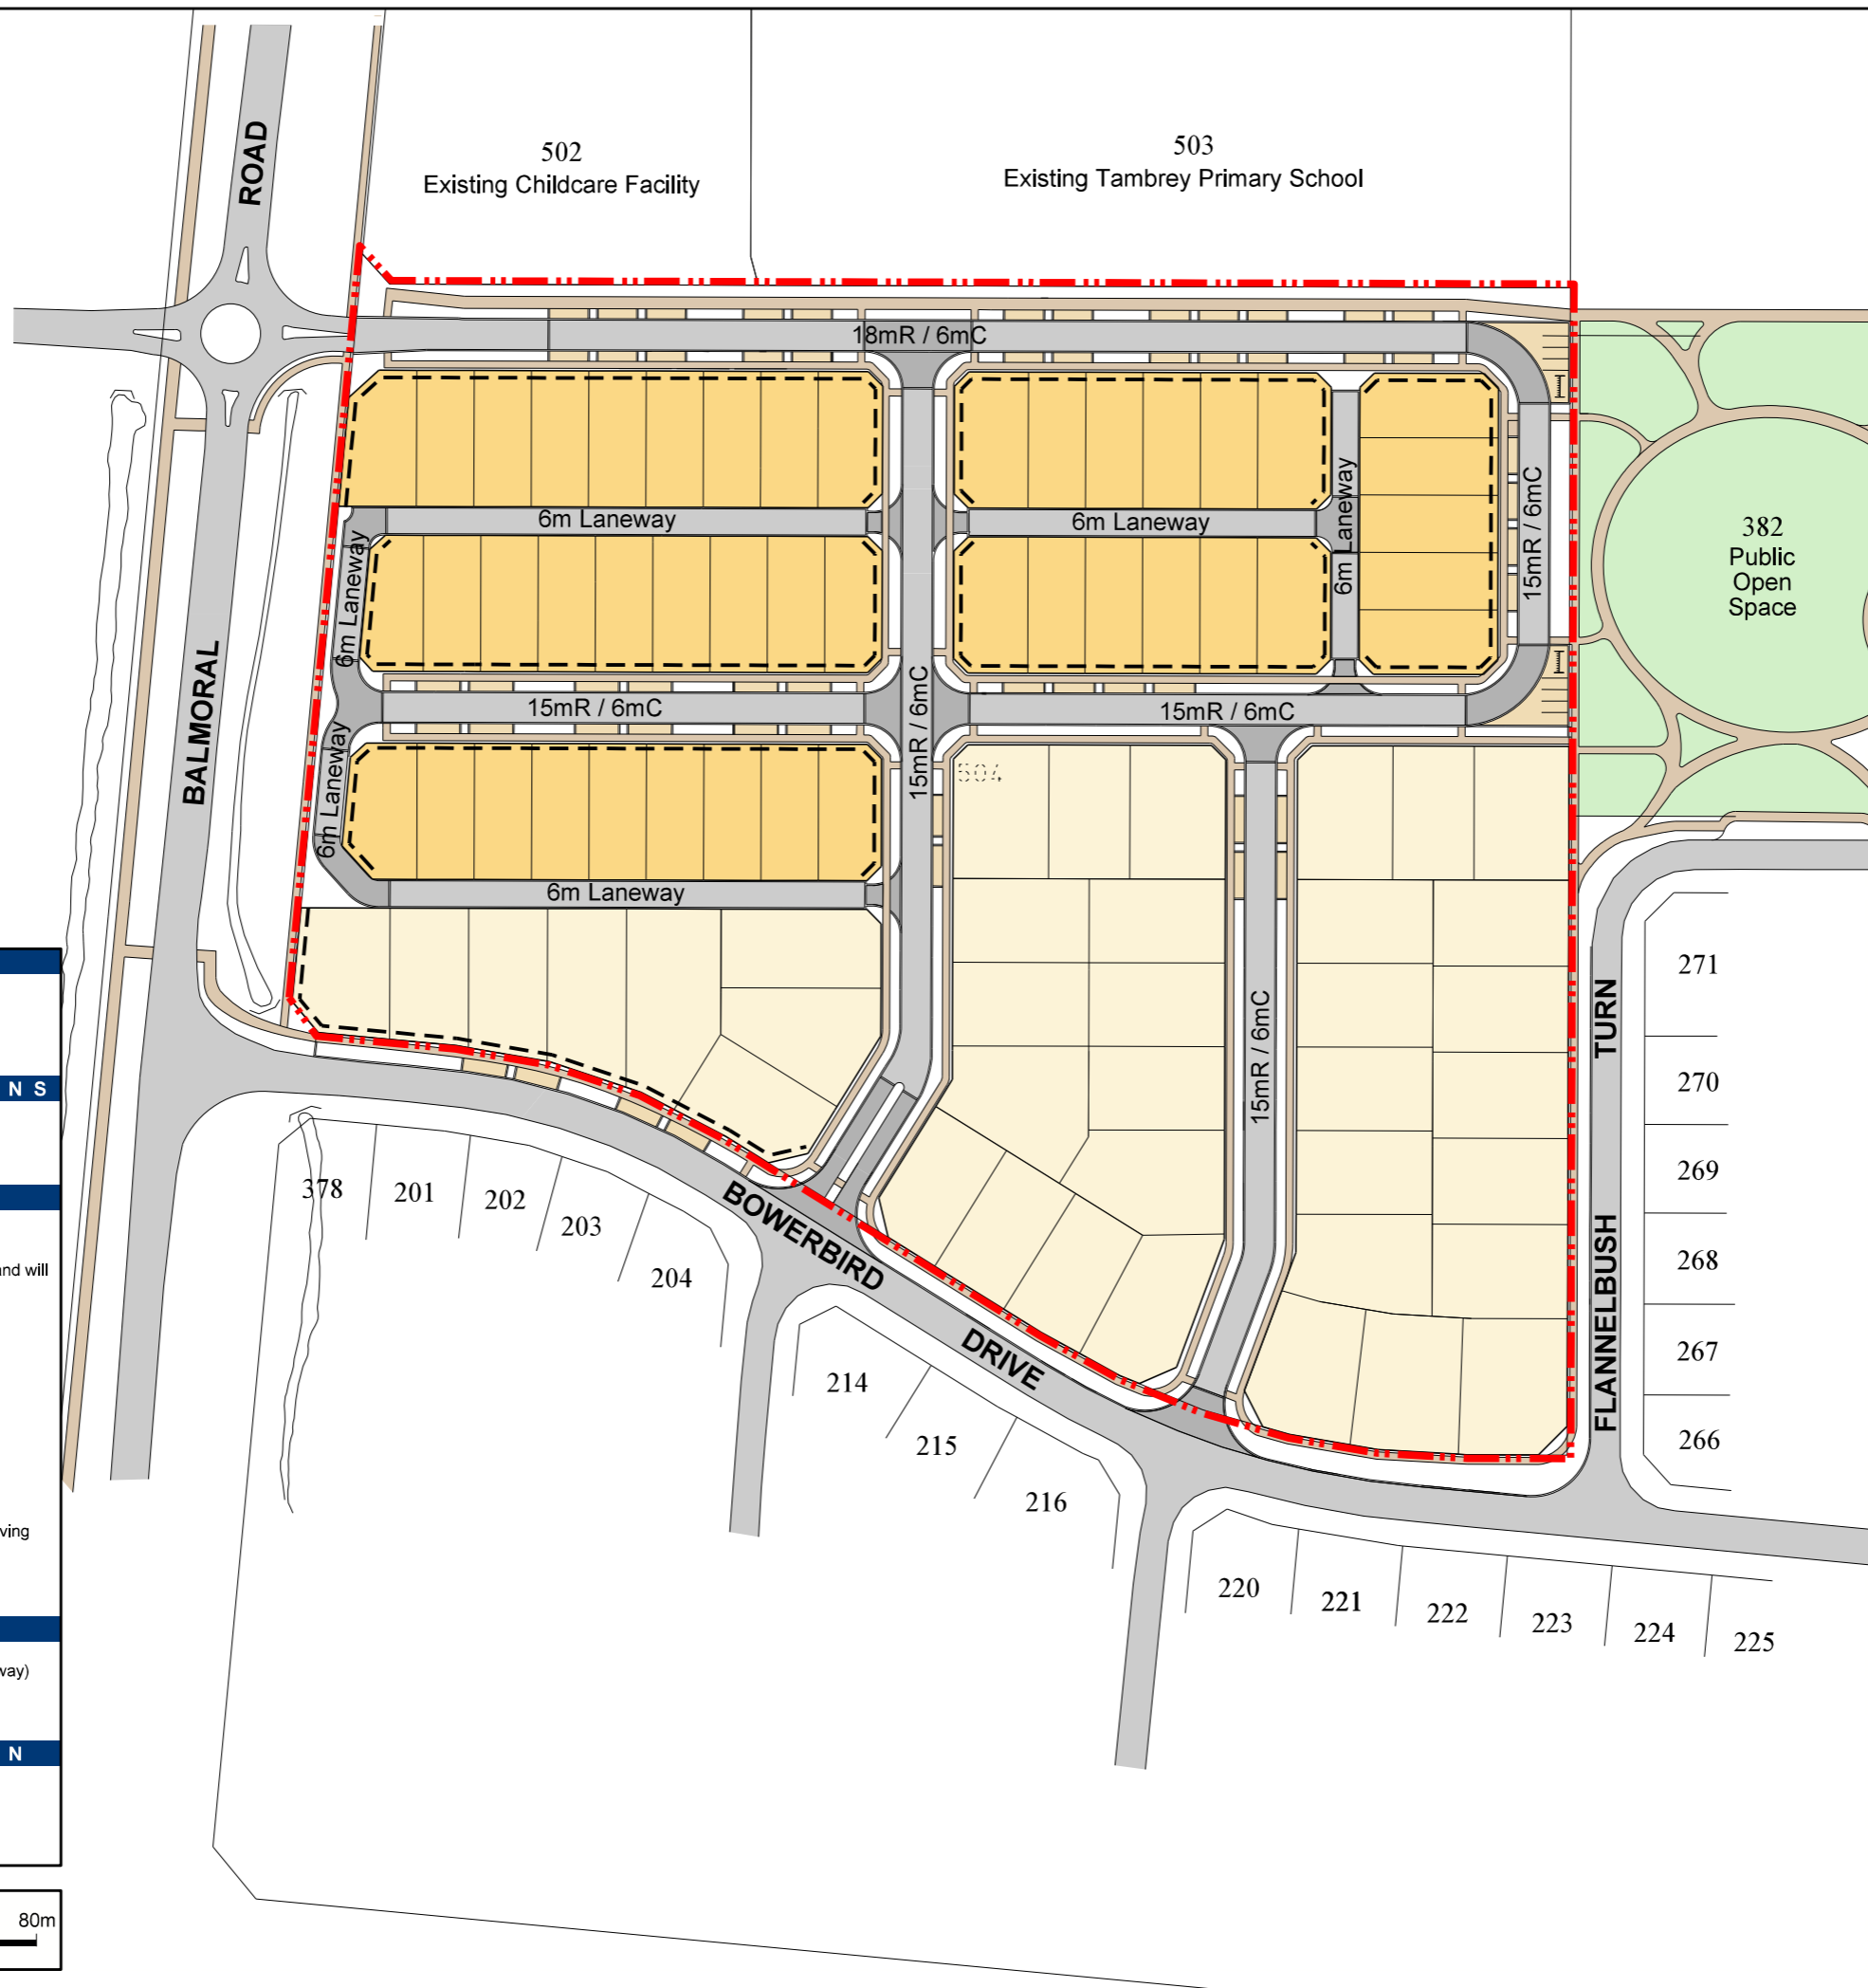
YIELD	
Residential R20	2.09ha
Residential R30	1.56ha

BUILT FORM PROVISIONS
Refer Part One, Section 9 of Development Plan report.

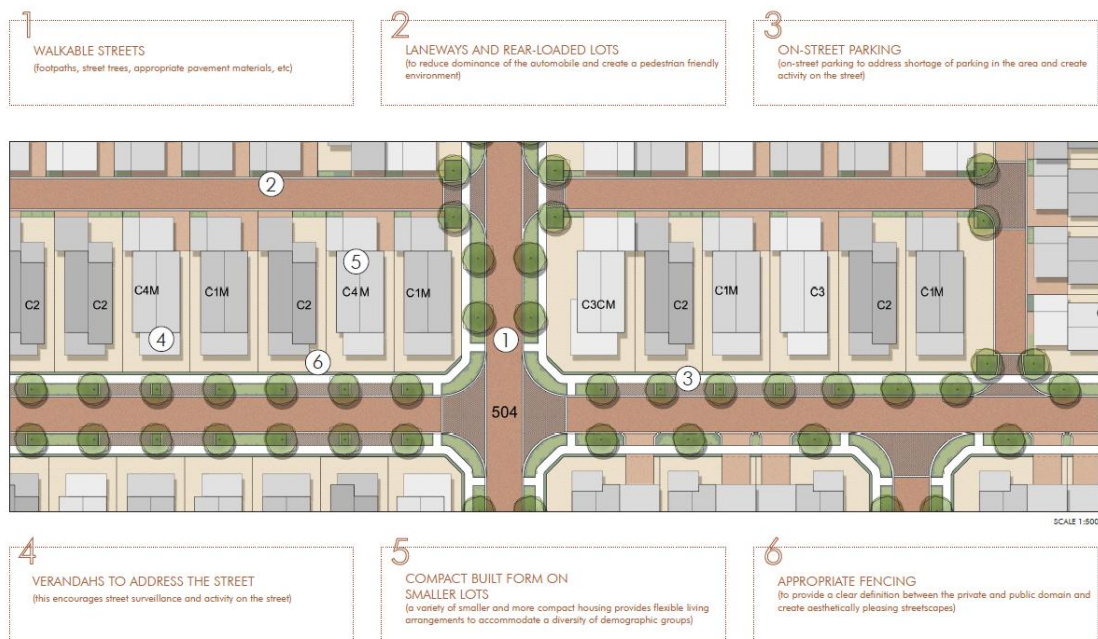
Figure 6: Design Features

- Embed the development with an identity unique to Karratha through a colour and materials palette reflective of the surrounding built and natural environment;
- Address parking shortages and create activity in the street through the provision of on-street parallel parking bays;
- The use of appropriate permeable fencing will provide a clear definition between the public and private domain and create aesthetically pleasing streetscapes;
- The provision of street trees to both sides of the street to provide, shade, scale and beauty to the streetscape; and
- Minimised front setbacks will ensure homes address the street, community interaction is promoted, and a more intimate scale to the streetscape is achieved.

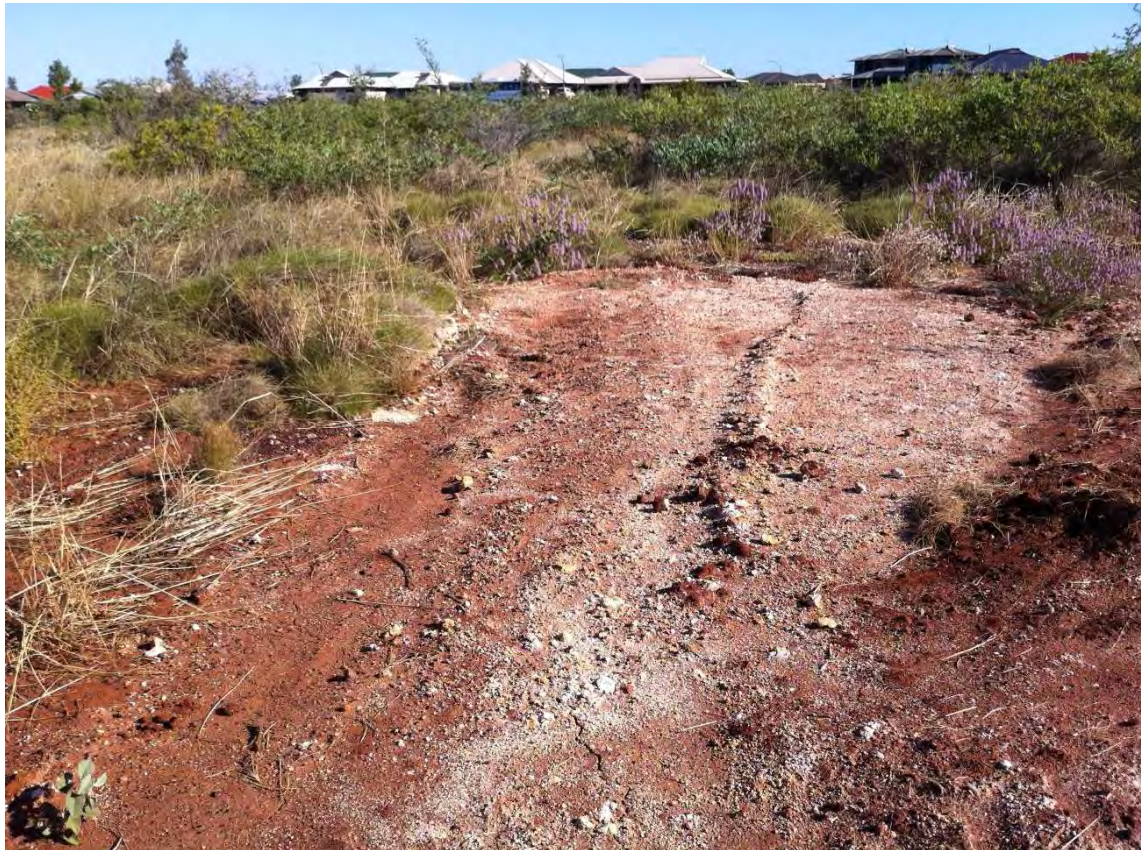
Plate 9: Ground disturbance, assumed geo-technical testing site (2011).

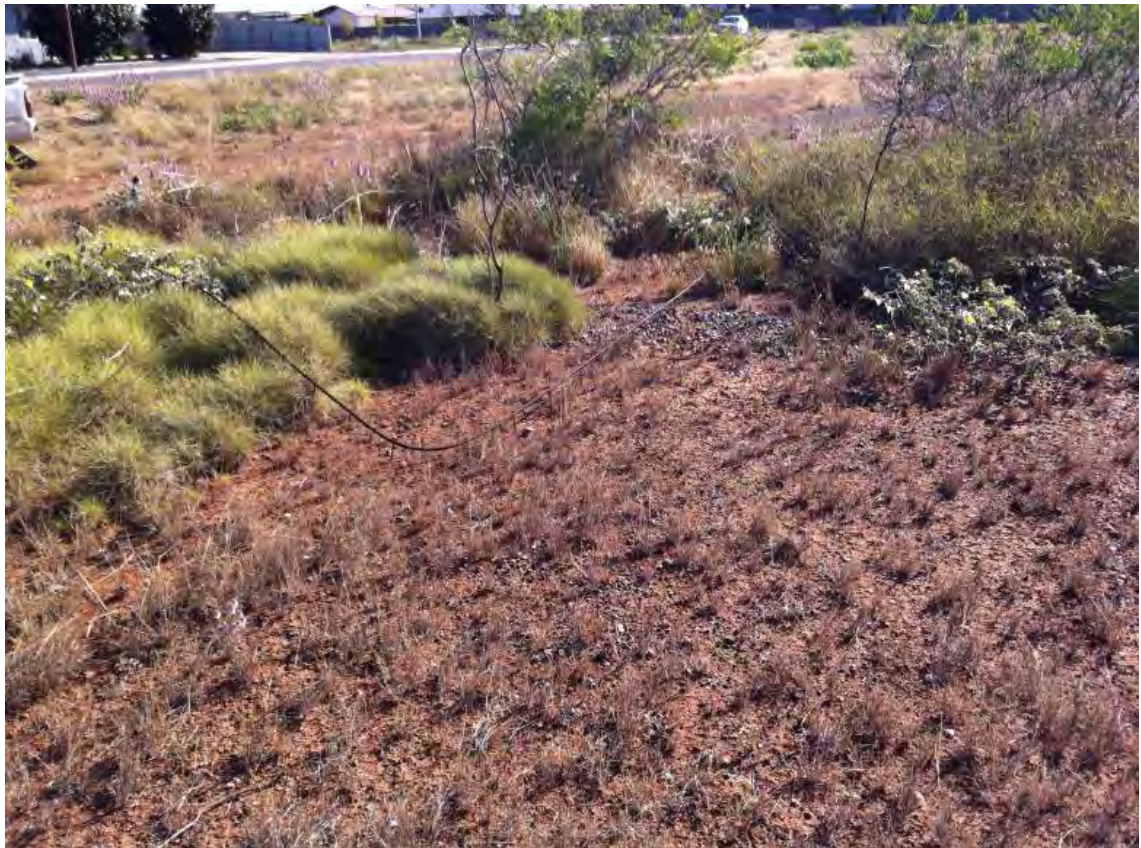
Plate 10: Construction waste (2011).

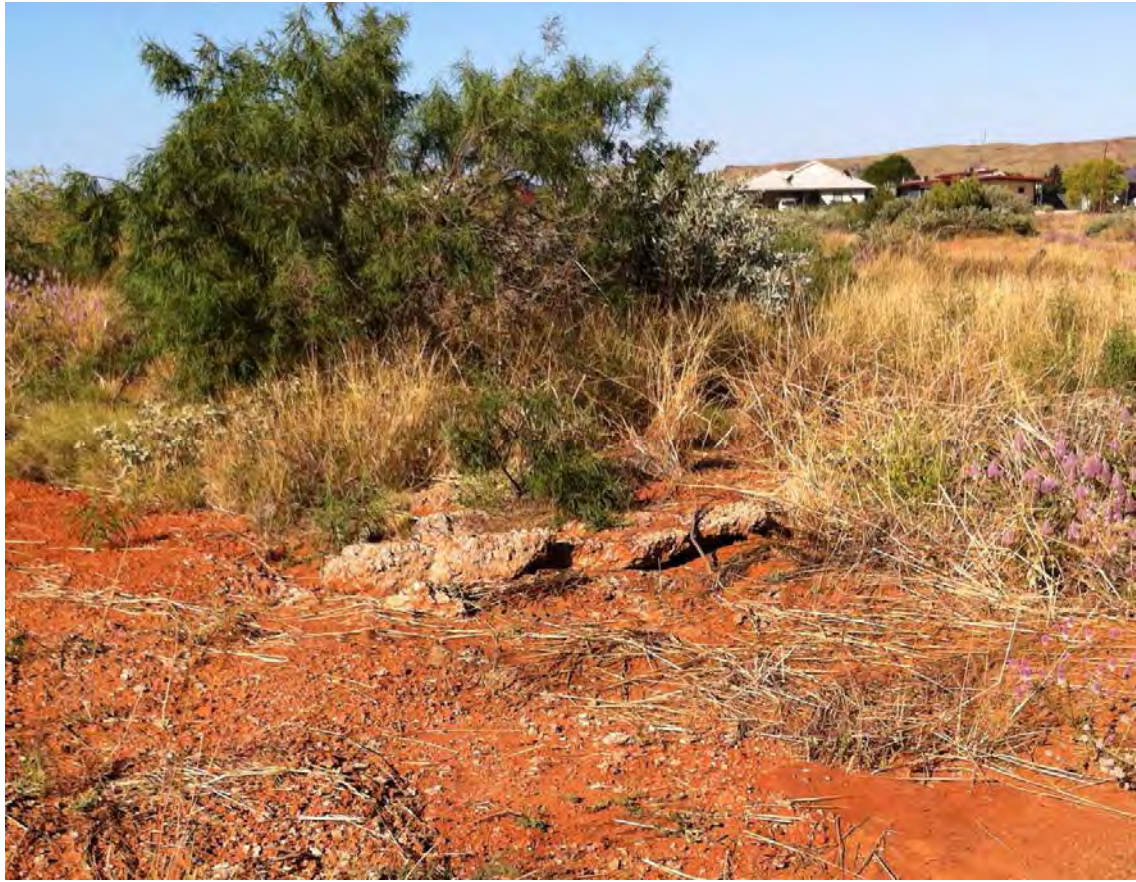
Plate 11: Construction waste (2011).

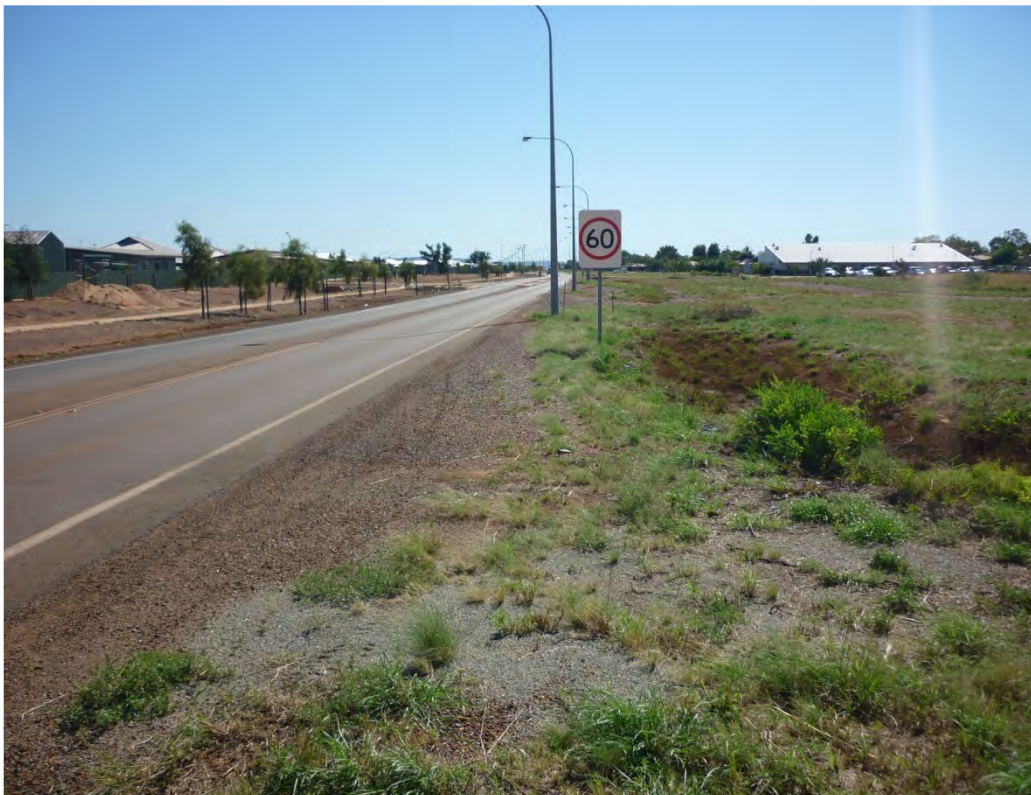
Bowerbird Drive connects to Balmoral Road at the south-west corner of the site at a T-intersection. Currently there is no provision for turning lanes or channelisation on Balmoral Road on the southern approach to the intersection with Bowerbird Drive although a short section of median has been constructed by the Shire to direct turning traffic into the appropriate lanes. Some localised widening and new seal has also been established but it is not sufficient for a vehicle to queue while performing a right hand turn without obstructing through traffic heading north.

Figure 2 Balmoral Road to the west of the site

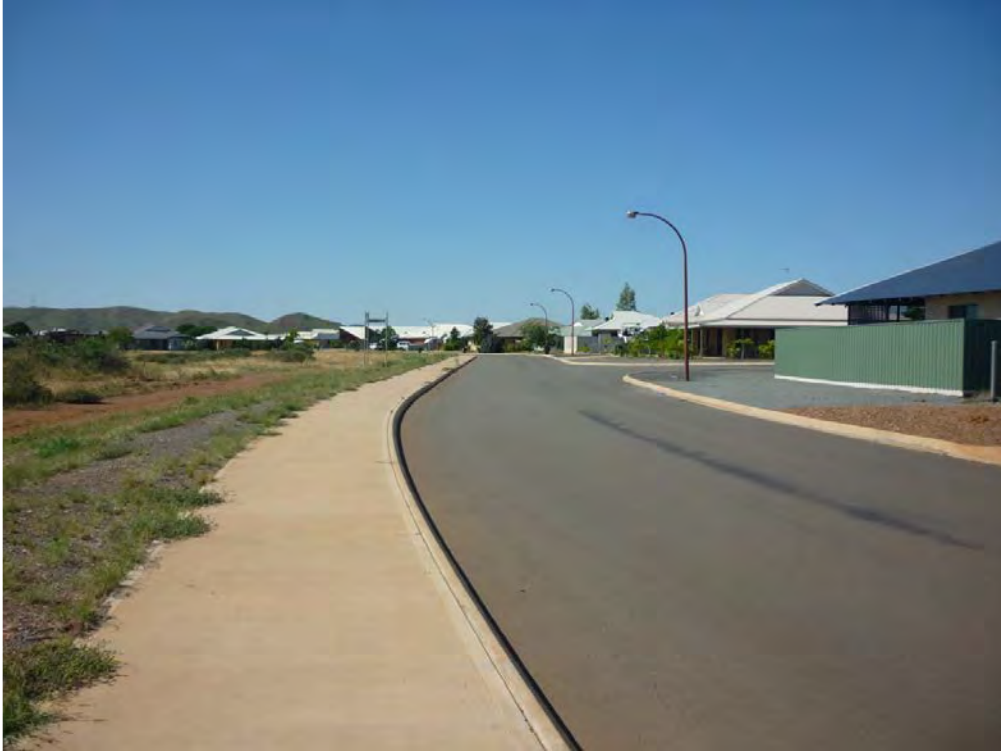
Both Bowerbird Drive and Flannelbush Turn are Neighbourhood Connectors with an approximate width of six metres and a speed limit of 50km/ hr. Both are paved with no line marking and have a footpath on one side. Bowerbird Drive is shown in **Figure 3** and Flannelbush Turn in **Figure 4**. To the north of Flannelbush Turn there is a park that also abuts to the site (see Figure 1).

Figure 3 Bowerbird Drive to the south of the site

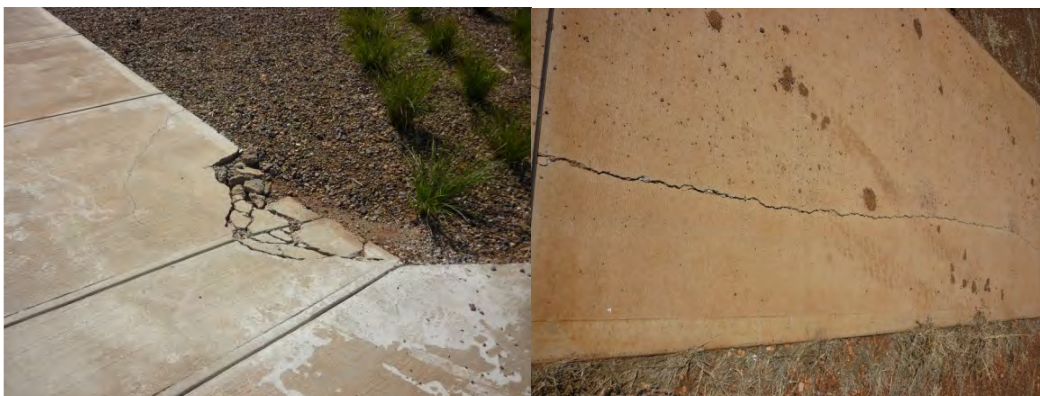
As discussed in Section 3.1, approximately 1.8 metre wide footpaths are provided on the north side of Bowerbird Drive and east side of Flannelbush Turn. In some locations, these paths are beginning to degrade with cracks becoming evident (see **Figure 8**) and are becoming overgrown with vegetation (principally a maintenance issue).

Figure 8 Examples of footpath deterioration adjacent to the site

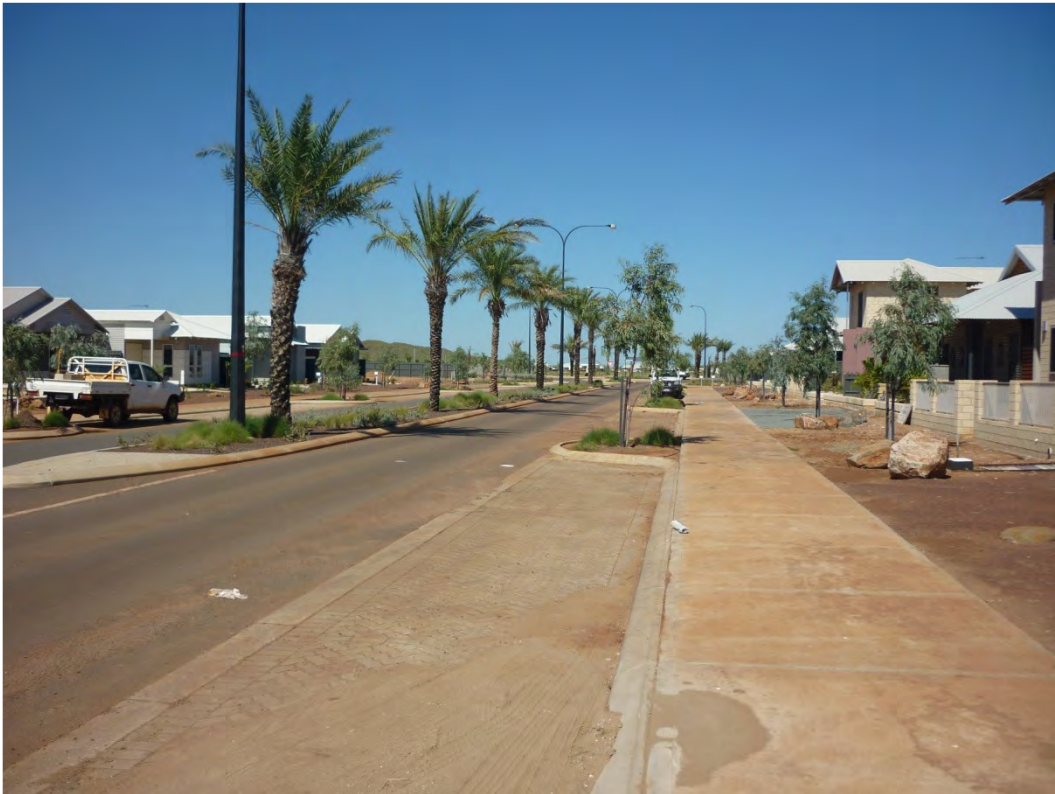
Residents parking should be provided on site as per the stipulations of the Residential Design Codes. On-street visitor car parking is considered the most efficient and appropriate method for provision of visitor car parking for residential access streets and the concept plan currently provides for this on most streets. On-street car parking can serve the additional role of reducing traffic speeds through reducing the visual width of the road reserve and provides a buffer between pedestrians and traffic. The Shire of Roebourne supports on-street parking and an example of on-street parking in the nearby Baynton West development can be seen in Figure 20.

Figure 20 Example of on-street parking provisions

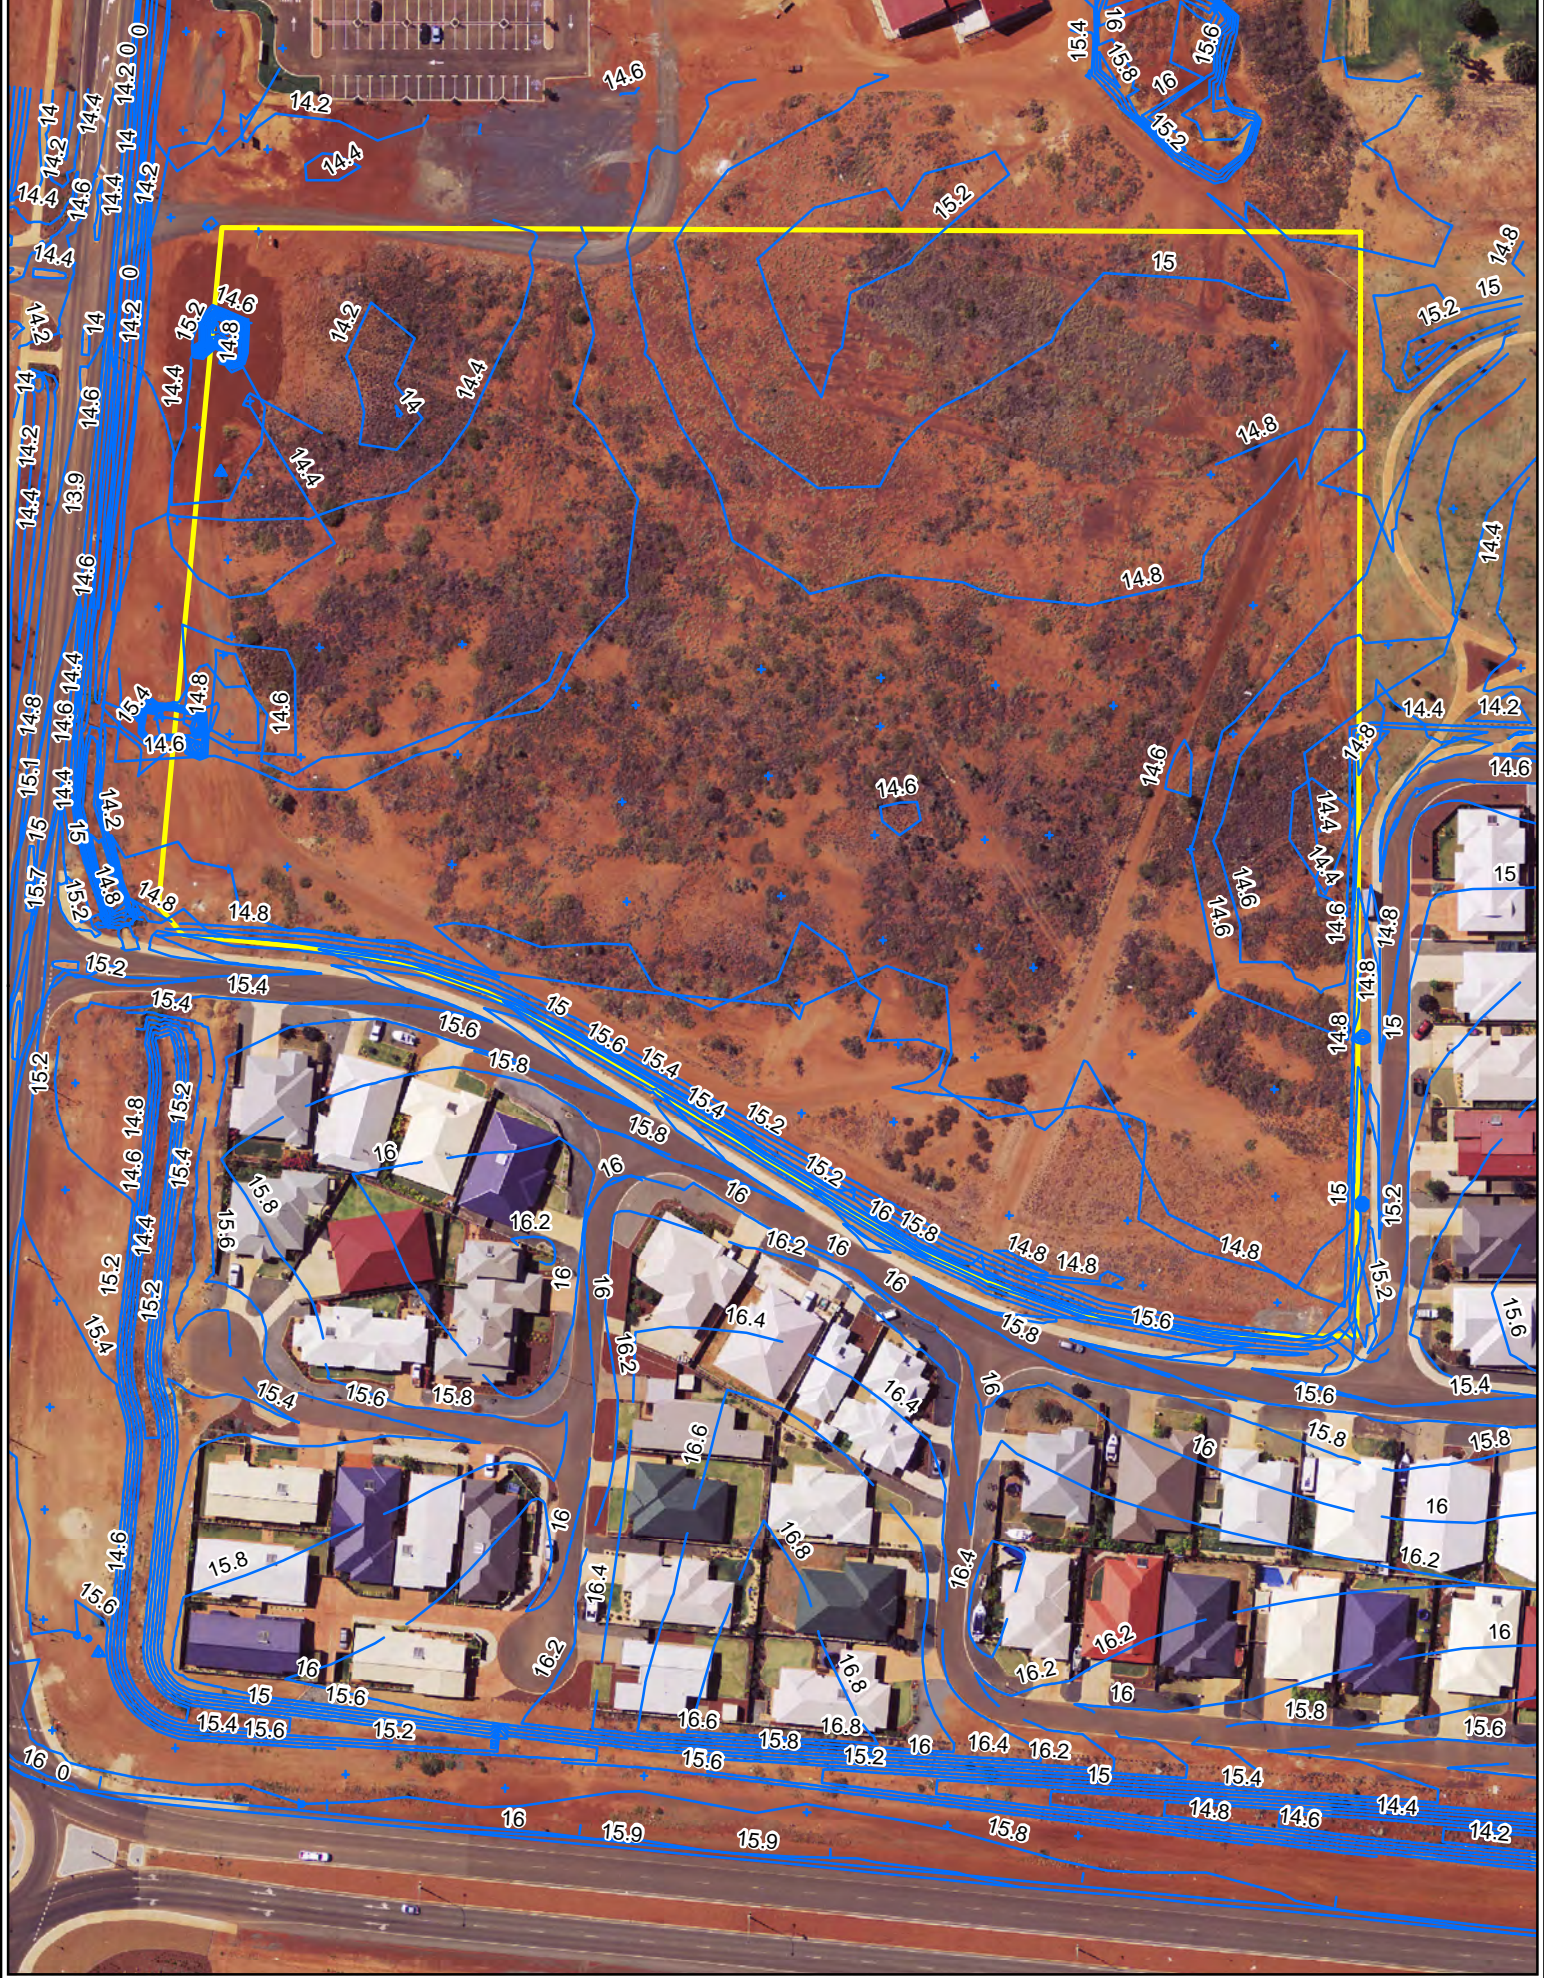
<p>Client: ABN Group</p>	<p>Project: Tambrey LWMS</p>	<p>Title: Figure 3: Topographic Contours</p>
<p>Meters</p>	<p>Legend</p> <ul style="list-style-type: none"> Site boundary Contours 	<p>Sources</p> <p>The following datasets were used in the production of this map:</p> <p>Contours - Whelans (2010)</p>
<p>07/10/11 :Date 1:1,800@A4 :Scale EP11-020(01)-F03 :Plan Number RLE :Checked DPC :Approved</p> <p>Notes: This drawing is the property of Emerge Associates and shall not be used without permission.</p>

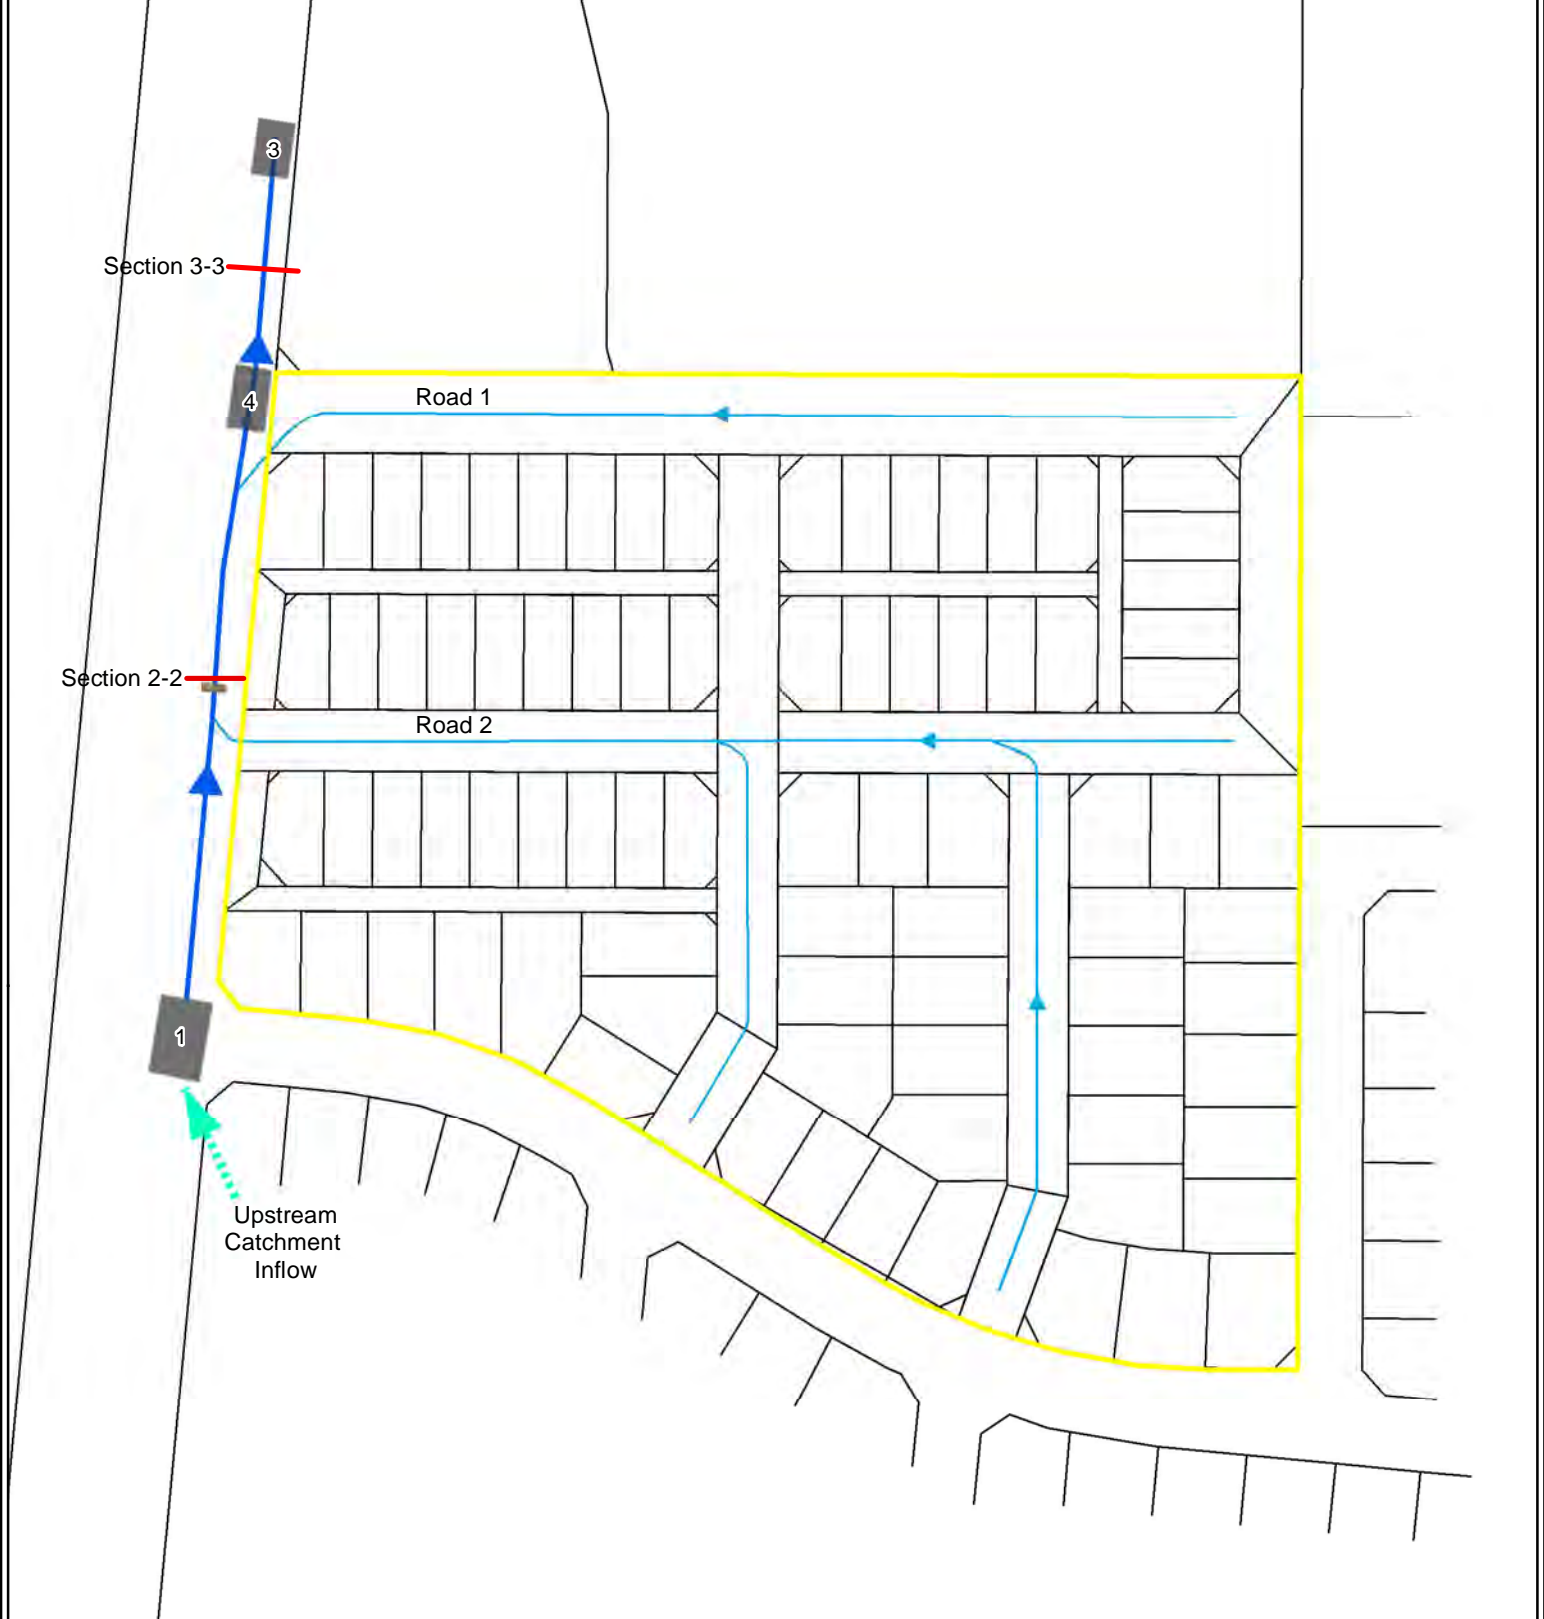
Client: ABN Group Project: Tambrey LWMS Title: Figure 5: Stormwater Management Features

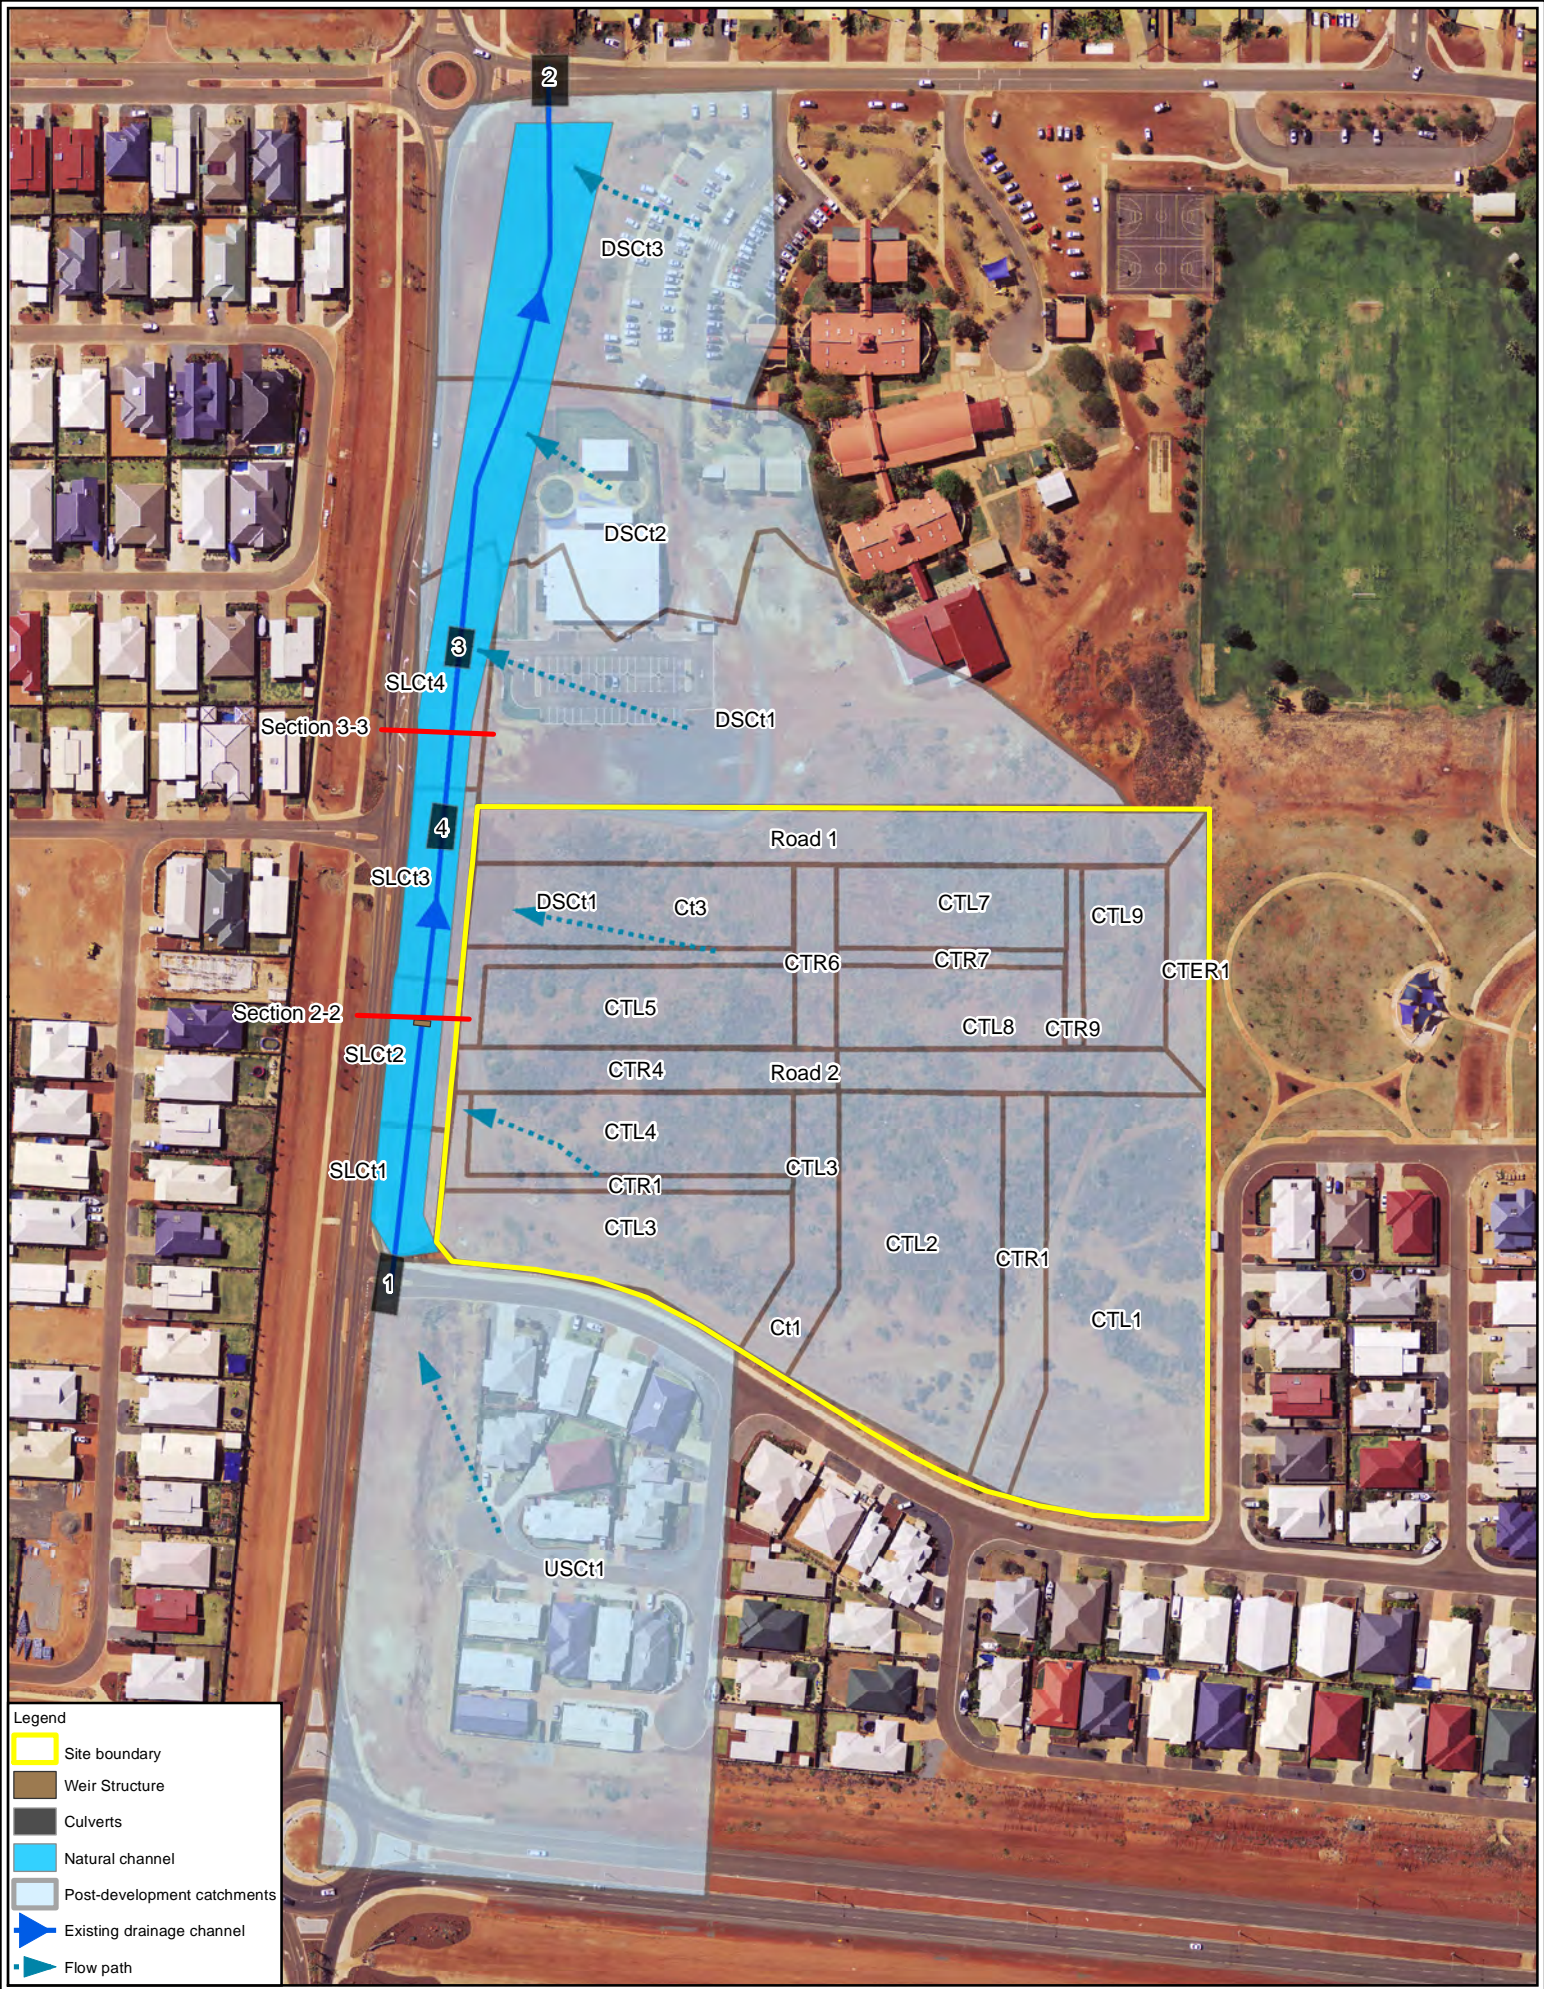
Client: ABN Group Project: Tambrey LWMS Title: Figure 6: Post Development Catchments

Figure 6: Post-development catchments

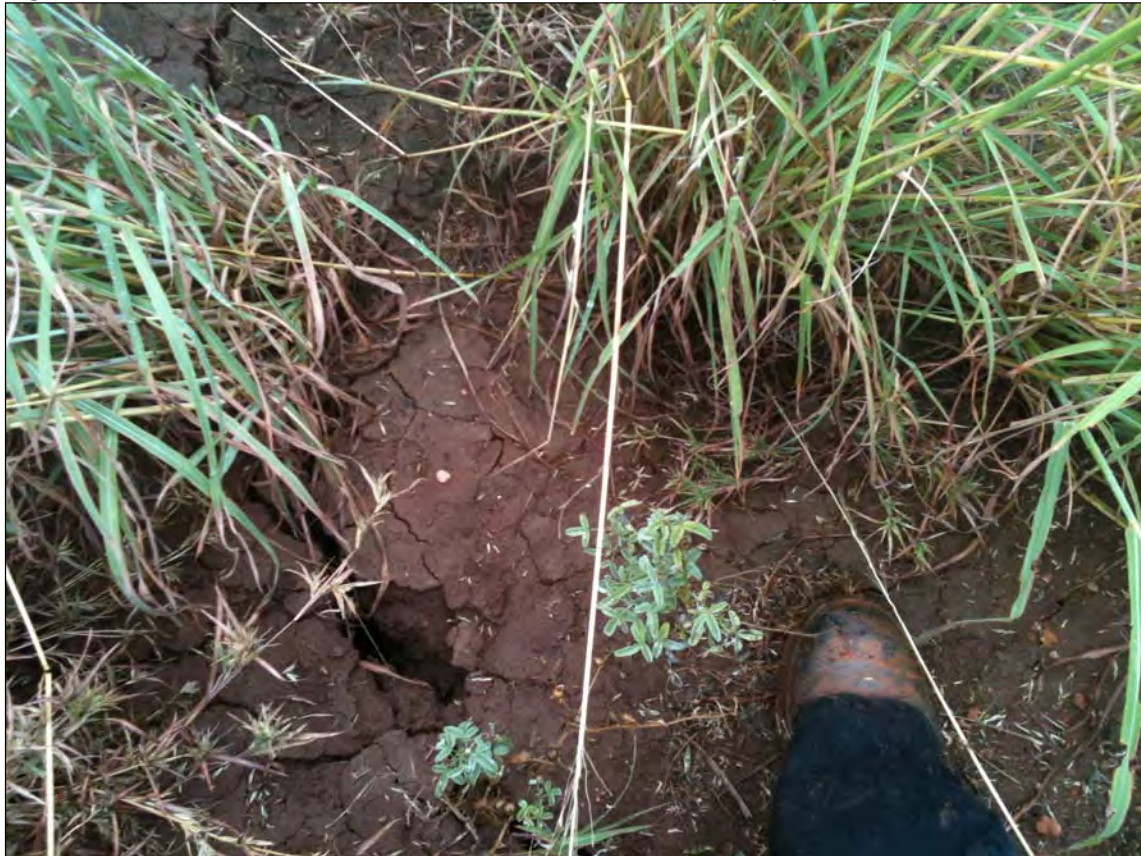
Figure 1: Cracks and 'crab holes' observed in the south-eastern part of the site
