# Roebourne townsite

## Environmental strategy

Prepared for Shire of Roebourne

By Essential Environmental

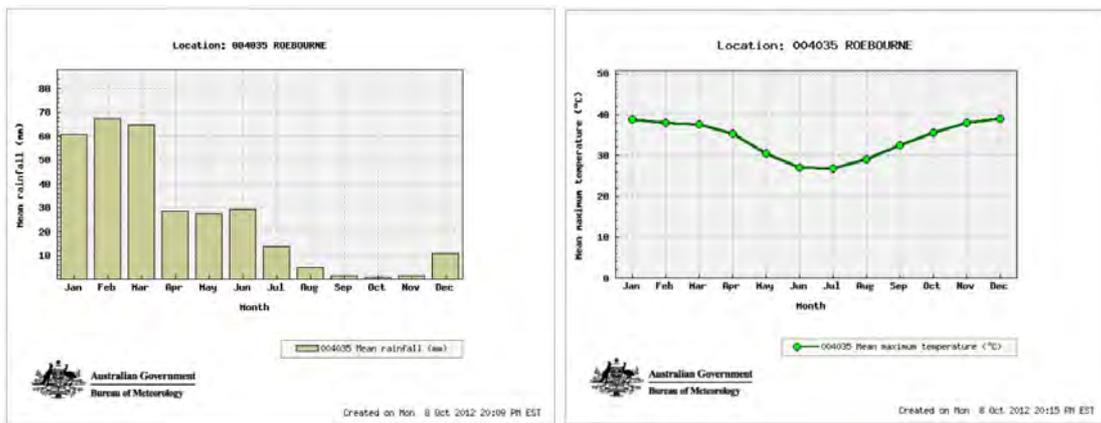
**Plate 1: Monthly mean temperature and rainfall at Roebourne (Source: Bureau of Meteorology)**

Both temperature and rainfall reach their maximum in summer, with temperature peaking in December at 39°C, and rainfall peaking at 67.5 mm in February. During the winter, the situation is reversed with maximum temperatures reaching their lowest point in July (approximately 27°C) whilst rainfall reaches its lowest amount, of approximately 0.7 mm, later in the year, in October (shown in Plate 1 below).

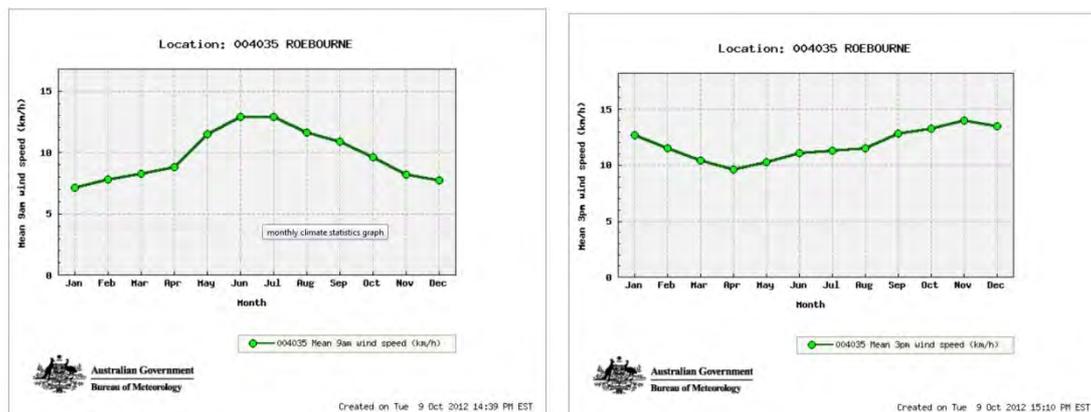
**Plate 2: Monthly mean wind speeds at 9am and 3pm at Roebourne (Source: Bureau of Meteorology)**

Wind data from the Bureau of Meteorology weather station in Roebourne shows that mean wind speeds are higher in winter in the morning (9am) and higher in summer in the afternoon (3pm), with mean monthly speeds ranging from 7 – 14 km/h at these times (Plate 2). Wind

direction in Roebourne is typically easterly in the morning (9am) and varies between a north-westerly and north-easterly direction in the afternoon (3pm).

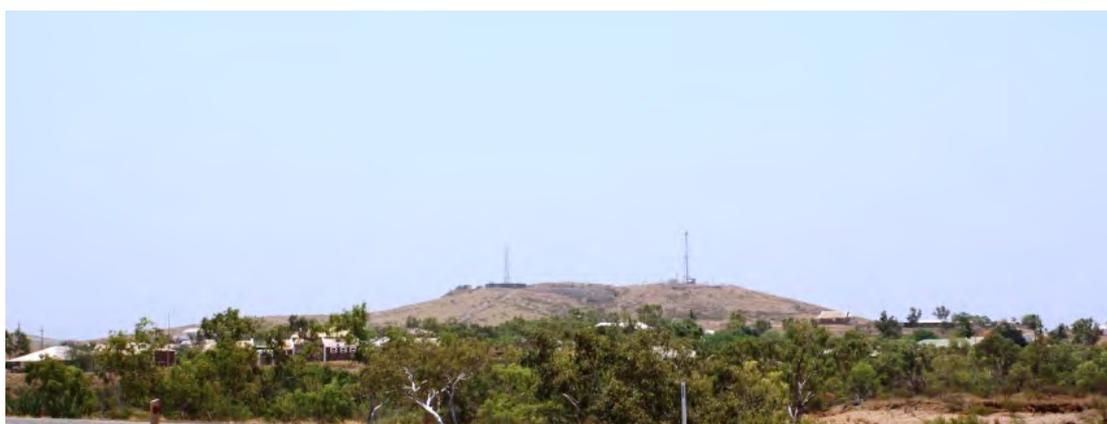
**Plate 3: Roebourne townsite around the foot of Mt Welcome**

The Roebourne townsite local structure plan area extends north-south, situated between a series of hills along the western boundary, peaking at Mount Welcome, with the Harding River along its eastern boundary. A smaller area of the Roebourne townsite lies separate from the main site, disconnected by the Harding River to the southeast.

The townsite local structure plan area is generally flat, most of which lies at an elevation between approximately 10 – 20 m AHD. However, a significant feature is Mount Welcome which peaks at approximately 70 m AHD and cuts through the central southern area of the townsite. A second, smaller hill peaking at approximately 38 m AHD cuts through the north of the townsite (Figure 4).

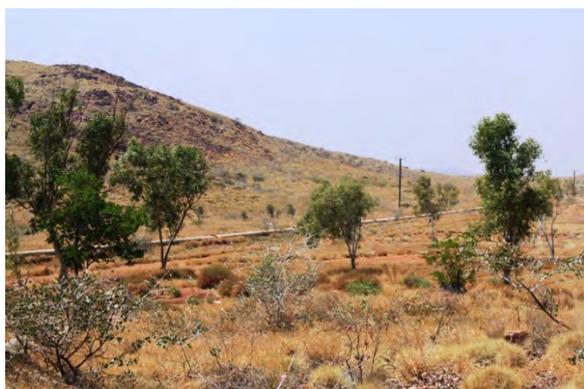
Plate 4: Mt Welcome from the west

Ridge lines west of the Roebourne townsite, including the highest point at Mount Welcome, are the defining landform of the townsite local structure plan area.

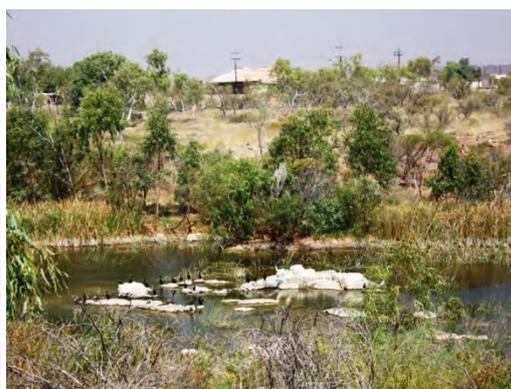
Plate 5: Riparian habitat of the Harding River

Just outside the structure plan area to the east, the riparian landscape of the Harding River is a contrasting but similarly distinctive landform.

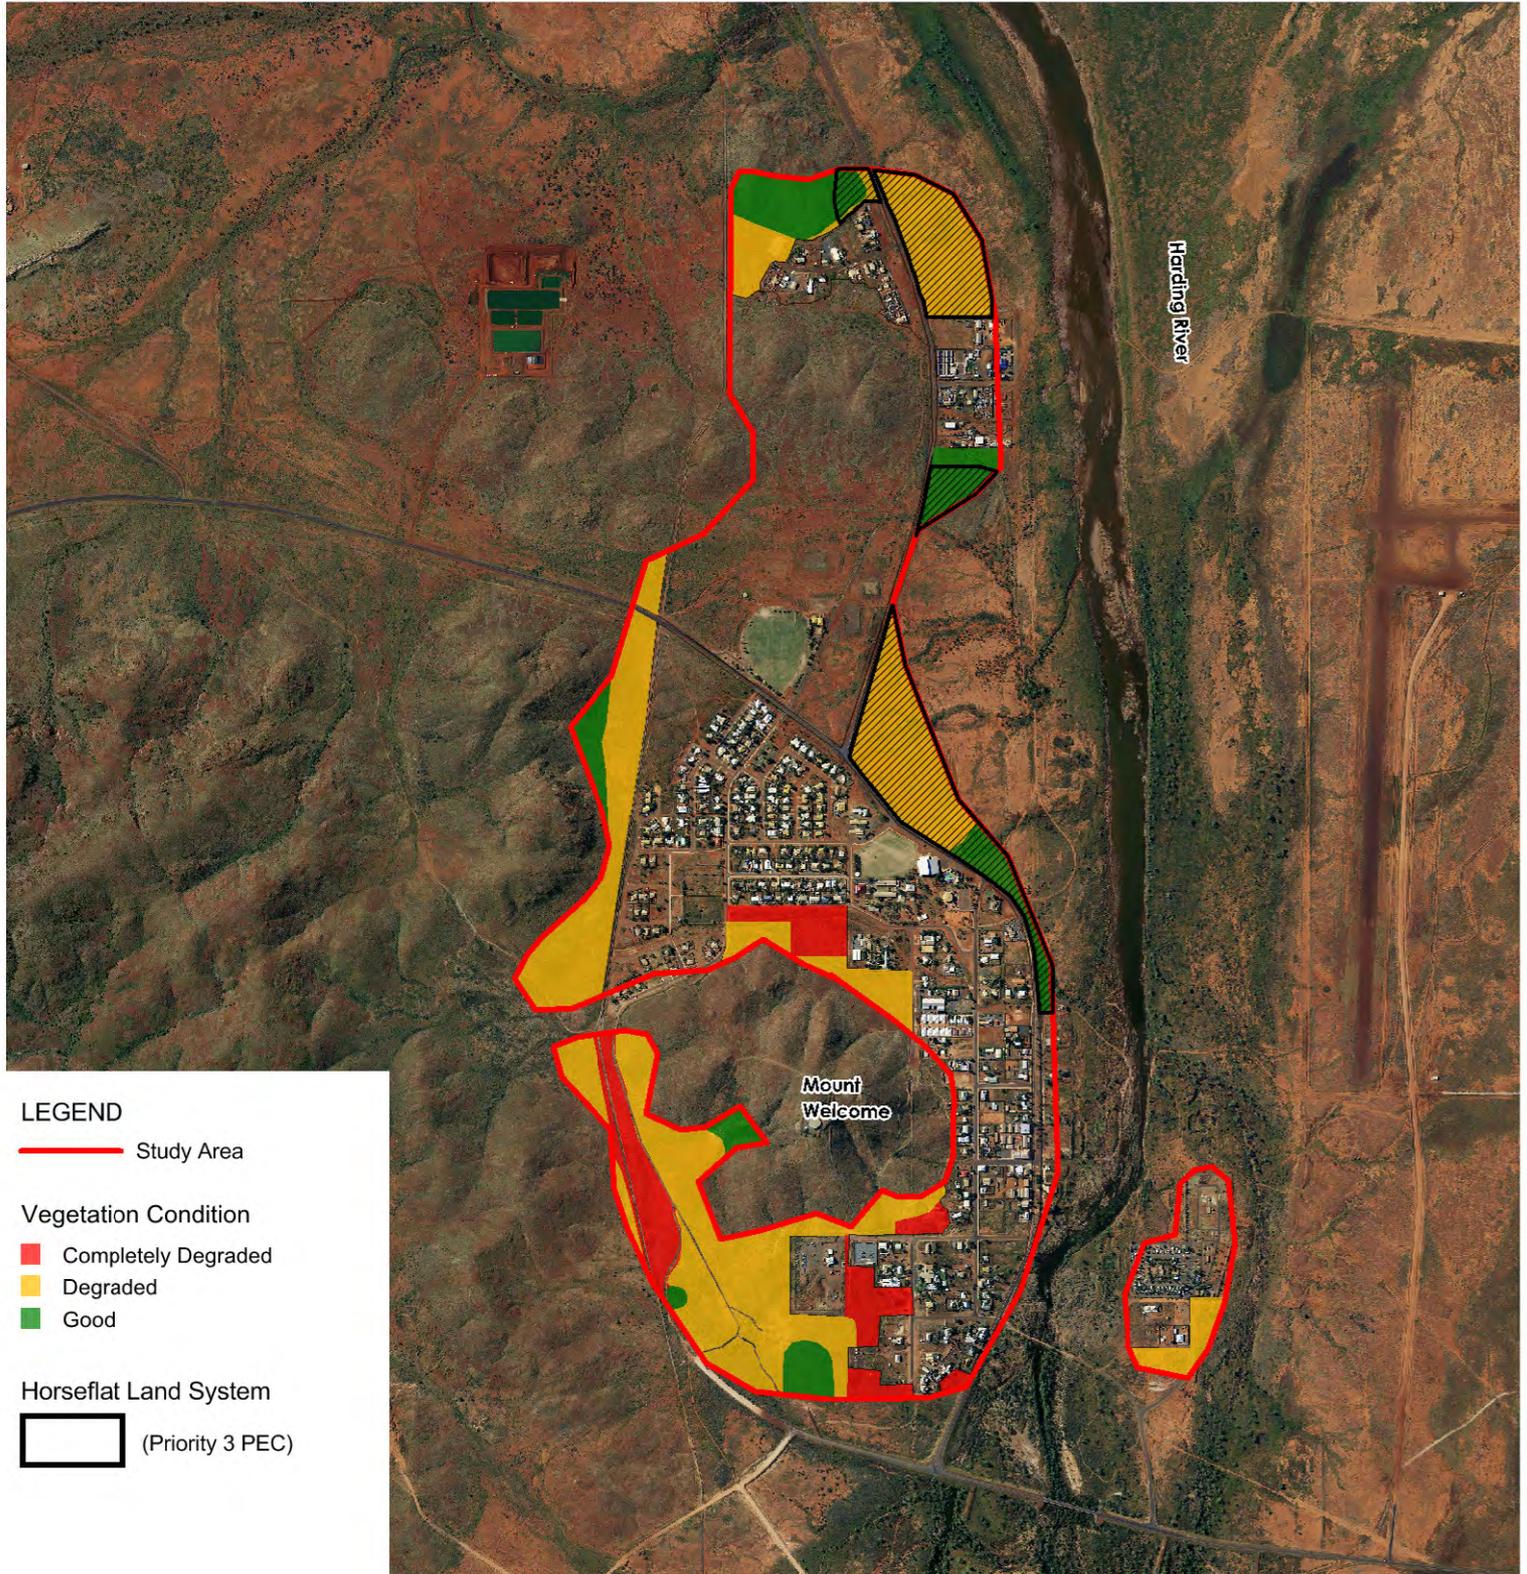
Shire of Roebourne - Roebourne Environmental Strategy  
 Figure 7: Vegetation condition

All vegetation communities in the study area have been subject to historic disturbances such as vegetation clearing, proliferation of tracks, historical grazing and rubbish dumping. These disturbances have modified the vegetation structure, increased weed invasion and reduced native species diversity across the majority of the study area. Vegetation condition ranged from Completely Degraded to Good with the majority of the study area described as being in Degraded condition (Figure 7).

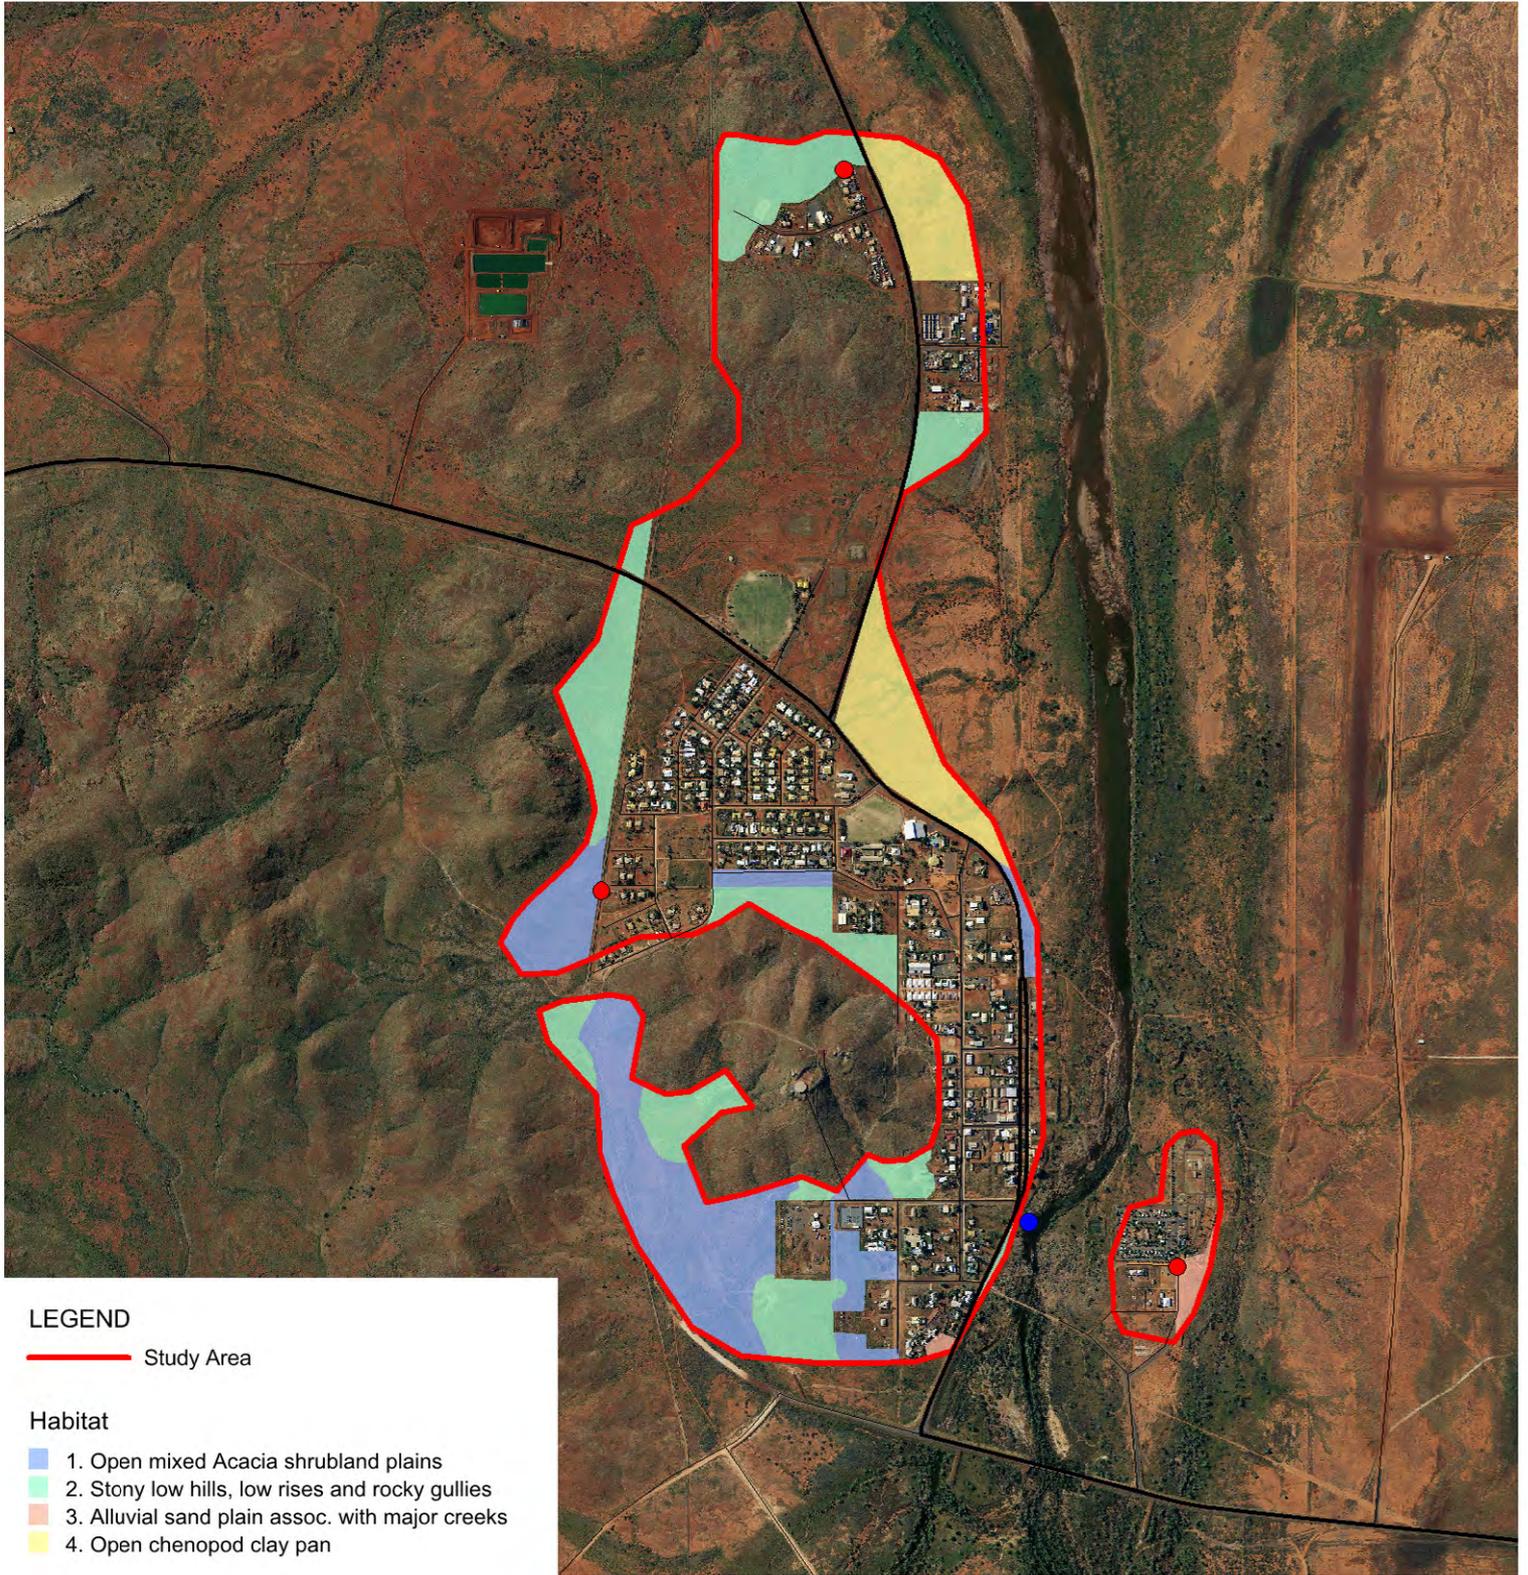
Shire of Roebourne - Roebourne Environmental Strategy  
 Figure 8: Fauna Habitat and Species

A total of 46 native fauna species were recorded during the Level 1 fauna survey. One mammal, four reptiles and 41 birds were identified during the survey of the study area. Fifteen of the 41 bird species recorded were observed within the Harding River on the eastern edge of the study area boundary.

- Rainbow Bee-eater (*Merops australis*) - observed in several locations within project area
- Great Egret (*Ardea alba*) - observed flying over the project area
- Cattle Egret (*Ardea ibis*) - observed in Harding River just beyond the project area
- Common Greenshank (*Tringa nebularia*) - observed in Harding River just beyond project area.

The Study area lacks several key fauna habitat characteristics including caves, significant rock outcrops, gorges, and riparian habitats. Therefore the site lacks core habitat for conservation significant fauna such as cave roosting bats, Northern Quolls, and Pilbara Olive Pythons. Based on the available habitat types and lack of core habitat, it is concluded that the site has few constraints to development. In addition, the relatively poor condition and high level of disturbance evident contribute to the low ecological value of the site in the context of the surrounding land and wider northern Pilbara in which there is extensive similar habitat types (Eco Logical, 2012).

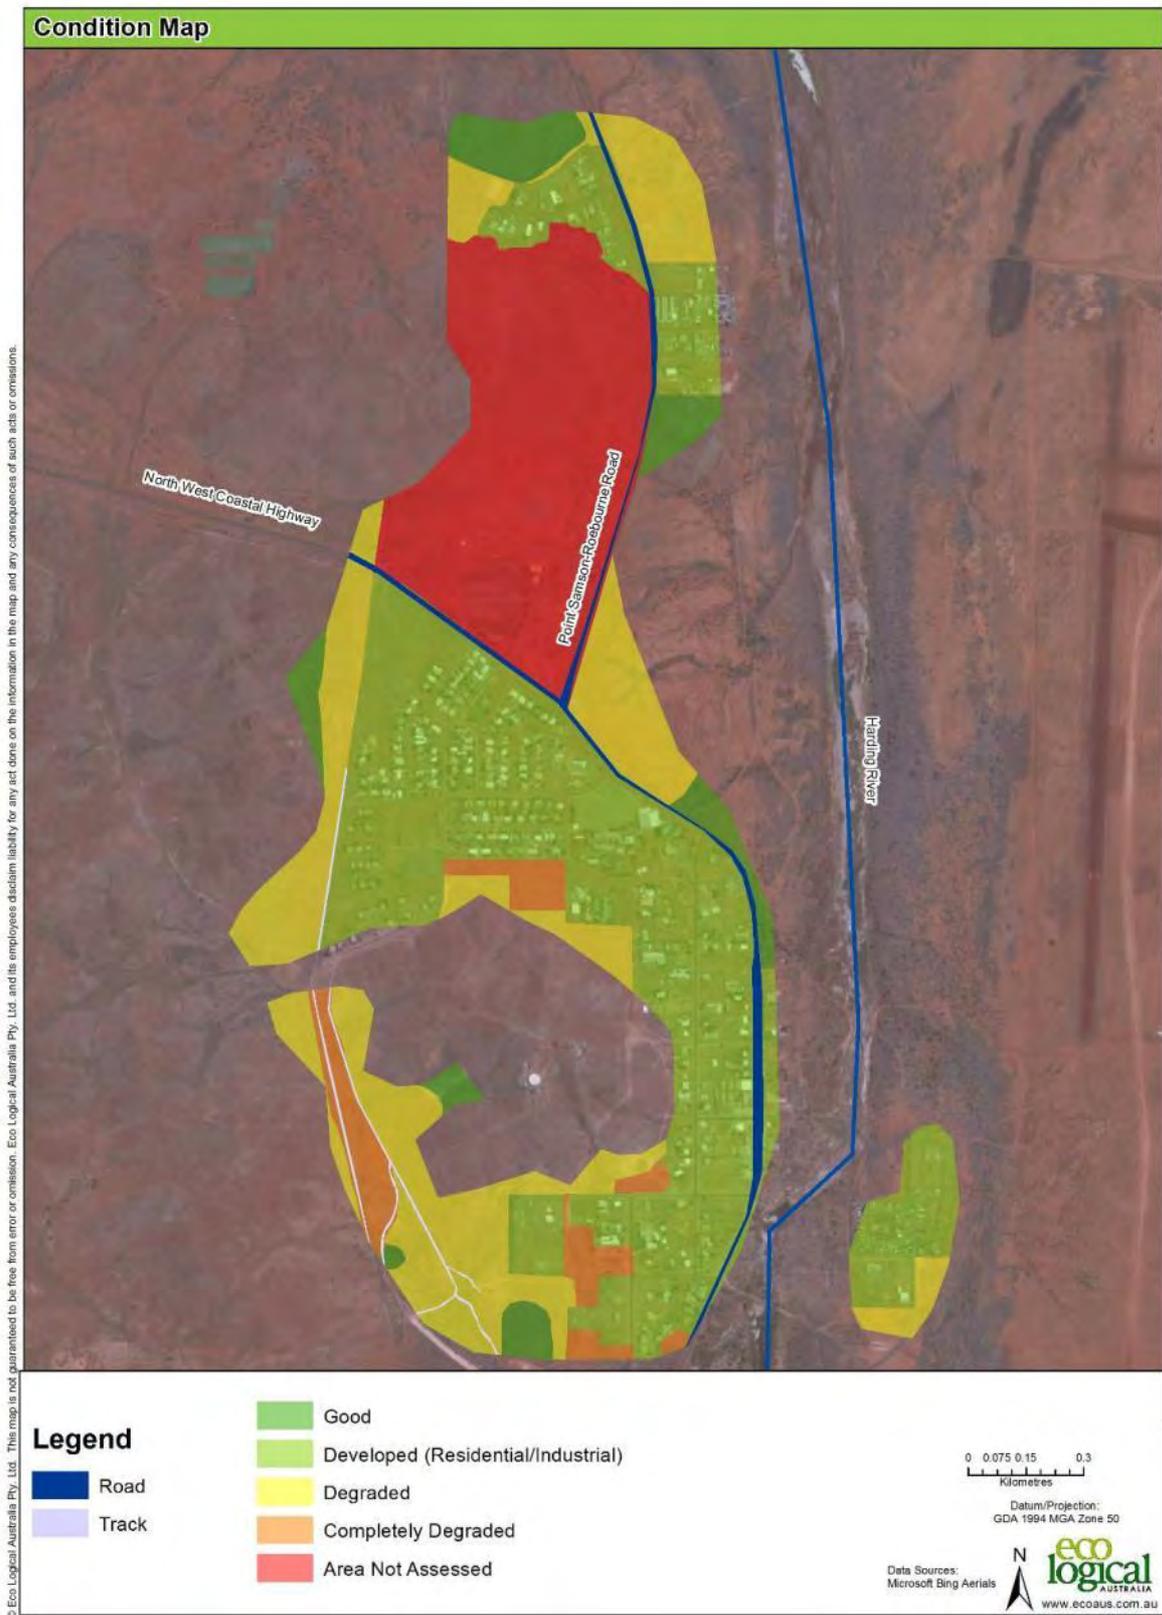
Figure 2: Vegetation condition of the Roebourne study area

All vegetation communities in the study area have been subject to historic disturbances such as vegetation clearing, proliferation of tracks, historical grazing and rubbish dumping. These disturbances have modified the vegetation structure, increased weed invasion and reduced native species diversity across the majority of the study area. Vegetation condition ranged from Completely Degraded to Good with the majority of the study area described as being in Degraded condition.

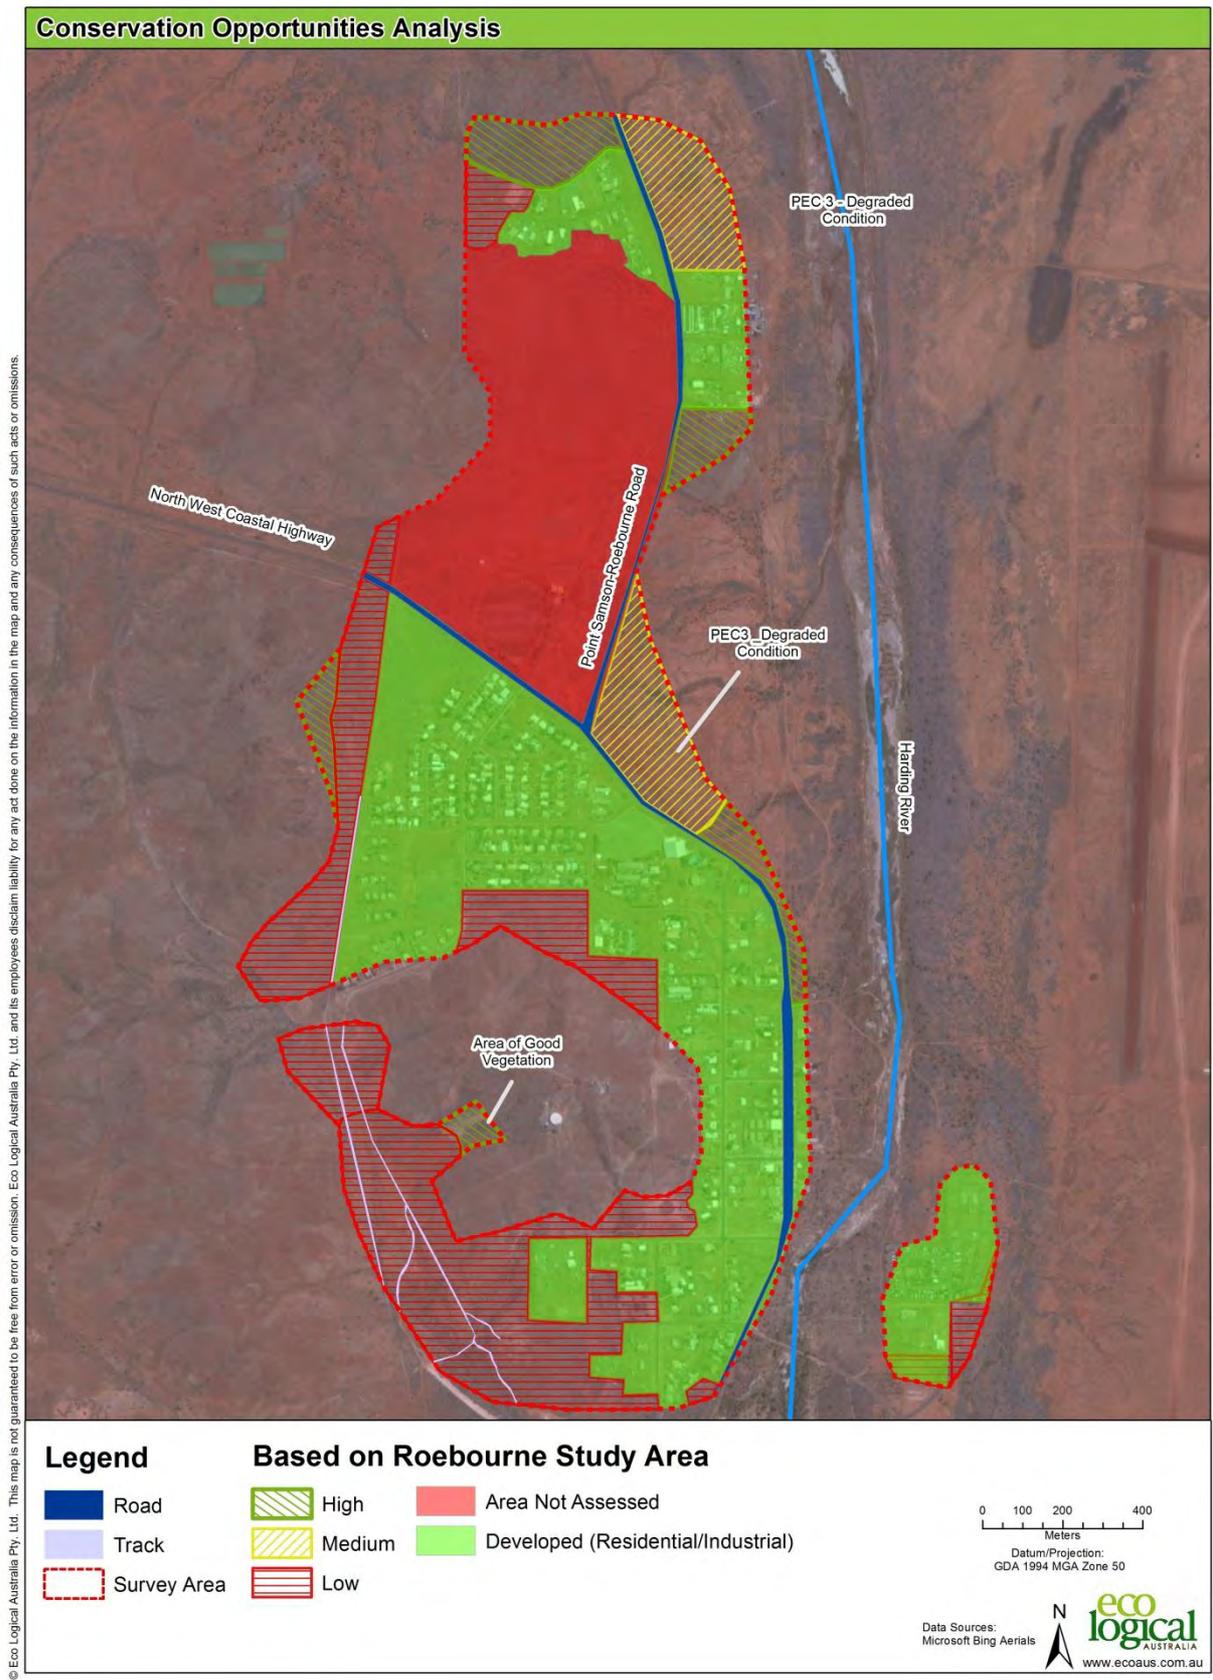
Figure 6: Conservation opportunities analysis of the study area

A conservation opportunities analysis was conducted to determine and rank areas in the study area that have High, Medium and Low conservation value. An assessment of these conservation values is provided to inform the Town of Roebourne of areas that contain higher value conservation assets to minimise potential environmental impacts on remaining areas of good vegetation. It should be noted however that the term “high” conservation value used in the context of this report does not indicate the presence of values that constitute a statutory constraint.

The relatively poor condition and high level of disturbance evident contribute to the low ecological value of the site in the context of the surrounding land and wider northern Pilbara in which there are very extensive areas of similar habitat types.

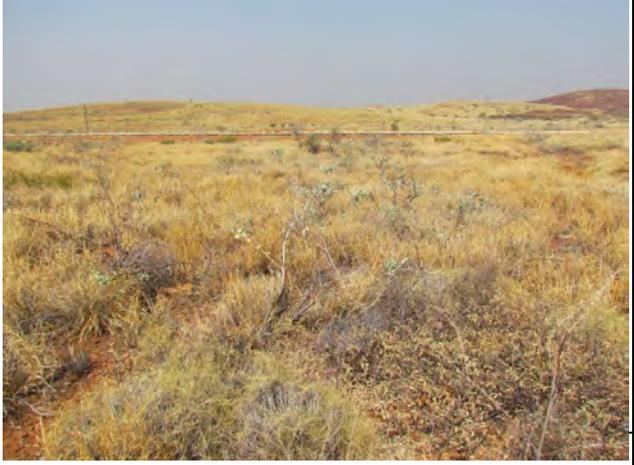
<b>Project area: Roebourne townsite</b>		<b>Releve # : ECO_37_01</b>		<b>Observer/s: JC</b>		
<b>Location</b>				<b>Datum: GDA94</b>		<b>Zone: 50J</b>
	<b>Coordinates: (UTM)</b>	E 0514242	N 7703166	WPT:	01JC	
<b>Habitat</b>	<b>Landform unit:</b>	Drainage plains and washes

<b>Rock type:</b>	Ironstone				
	<b>Soil:</b>					
	<b>Colour:</b>	Brown				
	<b>Type:</b>	Sandy loam				
	<b>Condition:</b>	Dry				
	<b>Outcropping:</b>	Nil				
	<b>Veg Condition:</b>	Degraded				
<b>Disturbance type:</b>	Weeds, Tracks, Clearing Rubbish					
<b>Age since fire (yrs):</b>	Approx 8+ yrs					
<b>Bare Soil (%): 5</b>		<b>Leaf litter (%): +</b>		<b>Logs (%): +</b>		
<b>Cover (%):</b>		Overstorey: +	Midstorey: 6	Understorey: 68		
<b>Vegetation description:</b>						
<i>Corymbia hamersleyana</i> scattered trees over <i>Acacia pyrifolia</i> , <i>Acacia bivenosa</i> and <i>Acacia arida</i> open shrubland over <i>Scaevola</i>

<i>spinescens</i> , <i>Corchorus walcottii</i> and <i>Salsola australis</i> scattered low shrubs over * <i>Cenchrus ciliaris</i> tussock grassland and <i>Triodia</i>						
<i>wiseana</i> very open hummock grassland

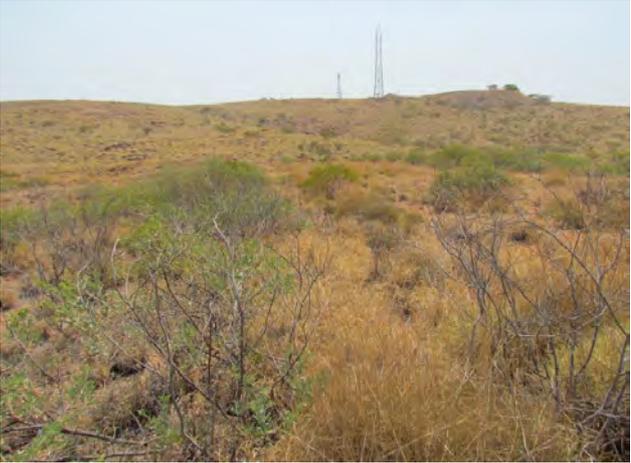
<b>Project area: Roebourne townsite</b>		<b>Releve # : ECO_37_02</b>		<b>Observer/s: JC</b>																					
<b>Location</b>				<b>Datum: GDA94</b>																					
				<b>Zone: 50J</b>																					
<b>Habitat</b>	<b>Coordinates: (UTM)</b>	E 0514451	N 7702994	WPT:	02JC

<table><tr> <td><b>Landform unit:</b></td> <td>Low rocky hill</td> <td rowspan="10" style="vertical-align: middle; text-align: center;">  </td> </tr><tr> <td><b>Rock type:</b></td> <td>Calcrete/Ironstone</td> </tr></table>

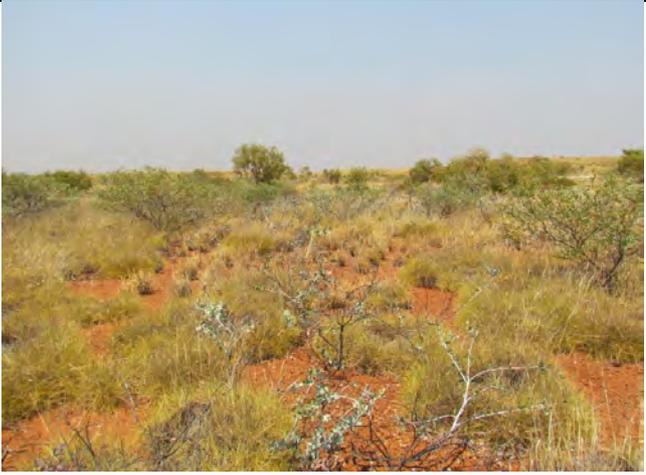
Project area: Roebourne townsite		Releve # : ECO_37_03		Observer/s: JC
Location				Datum: GDA94	Zone: 50J
	Coordinates: (UTM)	E 0514360	N 7702537	WPT:	03JC
Habitat	Landform unit:	Drainage plains and washes

Rock type:	Ironstone			
	Soil:				
	Colour:	Brown			
	Type:	Sandy loam			
	Condition:	Dry			
	Outcropping:	Nil			
	Veg Condition:	Good			
	Disturbance type:	Weeds, Tracks, Rubbish			
	Age since fire (yrs):	Approx 8+ yrs			
	Bare Soil (%): 15		Leaf litter (%): +	Logs (%): +	
	Cover (%):	Overstorey: 3	Midstorey: 35	Understorey: 48	
	<b>Vegetation description:</b>				
	<i>Corymbia hamersleyana</i> scattered trees over <i>Acacia bivenosa</i> and <i>Acacia pyrifolia</i> shrubland over				
	<i>Salsola australis</i> scattered low shrubs over * <i>Cenchrus ciliaris</i> very open tussock grassland and <i>Triodia wiseana</i>				
	hummock grassland

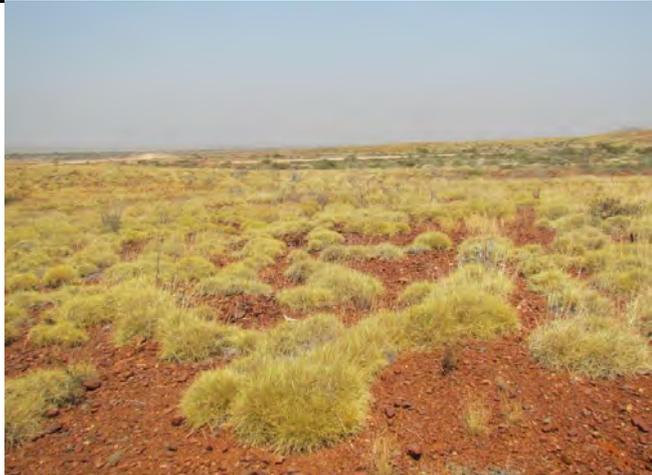
Project area: Roebourne townsite		Releve # : ECO_37_04		Observer/s: JC
Location	Datum: GDA94			Zone: 50J	
	Coordinates: (UTM)	E 0514679	N 7702457	WPT:	04JC
Habitat	Landform unit:	Low rocky hill slope			
	Rock type:	Ironstone			
	Soil:				
	Colour:	Red-Brown			
	Type:	Sandy loam			
	Condition:	Dry			
	Outcropping:	Nil			
Veg Condition:	Good				
Disturbance type:	Weeds, Tracks, Rubbish				
Age since fire (yrs):	Approx 5+ yrs				
	Bare Soil (%): 25		Leaf litter (%): +		Logs (%): +
	Cover (%):	Overstorey:	Midstorey: 2	Understorey: 55	
	Vegetation description:				
	<i>Acacia bivenosa</i> scattered shrubs over <i>Triodia wiseana</i> open hummock grassland and <i>Aristida contorta</i> scattered tussock				
	grasses

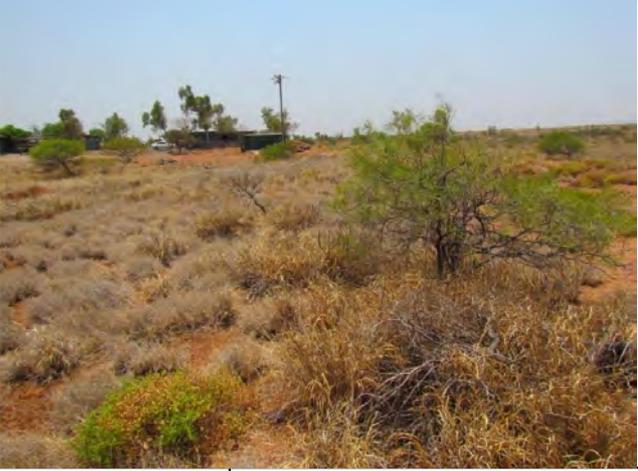
<b>Project area: Roebourne townsite</b>		<b>Releve # : ECO_37_05</b>		<b>Observer/s: JC</b>	
<b>Location</b>	<b>Datum: GDA94</b>			<b>Zone: 50J</b>	
	<b>Coordinates: (UTM)</b>	E 0515714	N 7702464	WPT:	06JC
<b>Habitat</b>	<b>Landform unit:</b>	Drainage plain

<b>Rock type:</b>	Ironstone			
	<b>Soil:</b>				
	<b>Colour:</b>	Brown			
	<b>Type:</b>	Sandy loam			
	<b>Condition:</b>	Dry			
	<b>Outcropping:</b>	Nil			
	<b>Veg Condition:</b>	Degraded			
<b>Disturbance type:</b>	Weeds, Tracks, Rubbish				
<b>Age since fire (yrs):</b>	Approx 5-8 yrs				
<b>Bare Soil (%): 20</b>		<b>Leaf litter (%): +</b>		<b>Logs (%): +</b>	
<b>Cover (%):</b>		Overstorey: 1	Midstorey: 1	Understorey: 60	
<b>Vegetation description:</b>					
<i>Eucalyptus camaldulensis</i> scattered trees over <i>Acacia sclerosperma</i> subsp. <i>sclerosperma</i> scattered shrubs over					
<i>Salsola australis</i> scattered low shrubs over * <i>Cenchrus ciliaris</i> and <i>Eragrostis xerophila</i> tussock grassland

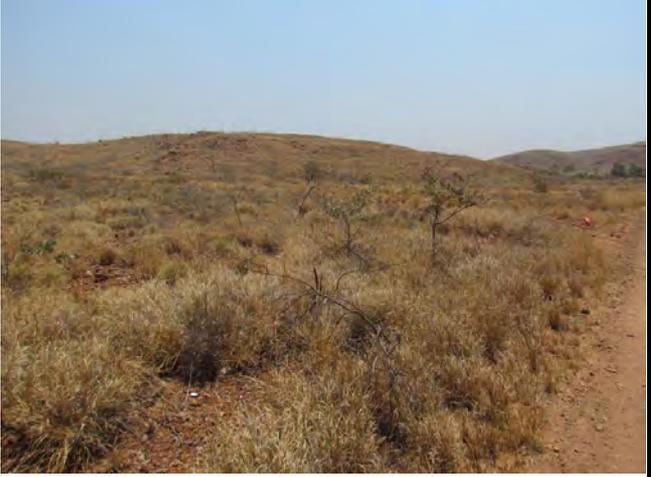
<b>Project area: Roebourne townsite</b>		<b>Releve # : ECO_37_06</b>		<b>Observer/s: JC</b>	
<b>Location</b>				<b>Datum: GDA94</b>	
				<b>Zone: 50J</b>	
<b>Coordinates: (UTM)</b>	E 0514719		N 7703432		WPT: 08JC
<b>Habitat</b>	<b>Landform unit:</b>	Low rocky hill and gentle slopes			
	<b>Rock type:</b>	Ironstone			
	<b>Soil:</b>				
	<b>Colour:</b>	Brown			
	<b>Type:</b>	Sandy loam			
	<b>Condition:</b>	Dry			
	<b>Outcropping:</b>	Nil			
	<b>Veg Condition:</b>	Degraded			
	<b>Disturbance type:</b>	Weeds, Tracks, Rubbish, Clearing			
	<b>Age since fire (yrs):</b>	Approx 5-8 yrs			
<b>Bare Soil (%): 5</b>		<b>Leaf litter (%): +</b>		<b>Logs (%): +</b>	
<b>Cover (%):</b>		Overstorey:	Midstorey: 4	Understorey: 65	
<b>Vegetation description:</b>					
<i>Acacia pyrifolia</i> and <i>Acacia inaequiletera</i> open shrubland over <i>Triodia wiseana</i> very open hummock grassland and

* <i>Cenchrus ciliaris</i> and <i>Aristida contorta</i> tussock grassland

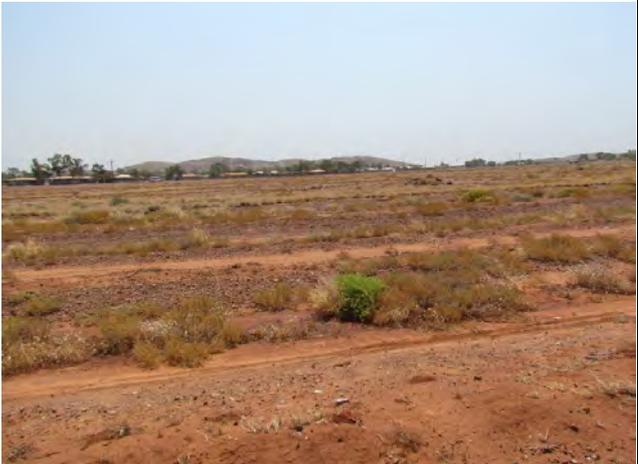
<b>Project area: Roebourne townsite</b>		<b>Releve # : ECO_37_07</b>		<b>Observer/s: JC</b>	
<b>Location</b>	<b>Datum: GDA94</b>			<b>Zone: 50J</b>	
	<b>Coordinates: (UTM)</b>	E 0515059	N 7703891	WPT:	09JC
<b>Habitat</b>	<b>Landform unit:</b>	Low plain

<b>Rock type:</b>	Ironstone and calcrete small pebbles			
	<b>Soil:</b>				
	Colour:	Light-Brown			
	Type:	Clay loam			
	Condition:	Dry			
	<b>Outcropping:</b>	Nil			
	<b>Veg Condition:</b>	Degraded			
	<b>Disturbance type:</b>	Weeds, Tracks, Rubbish, Clearing, earthworks			
	<b>Age since fire (yrs):</b>	10 + yrs			
<b>Bare Soil (%): 50</b>		<b>Leaf litter (%): +</b>		<b>Logs (%): +</b>	
<b>Cover (%):</b>		Overstorey:	Midstorey: 6	Understorey: 25	
<b>Vegetation description:</b>					
<i>Acacia xiphophylla</i> scattered shrubs over <i>Sclerolaena cuneata</i> , <i>Atriplex bunburyana</i> and <i>Salsola australis</i> scattered low					
shrubland over * <i>Cenchrus ciliaris</i> and <i>Eragrostis eriopoda</i> open tussock grassland

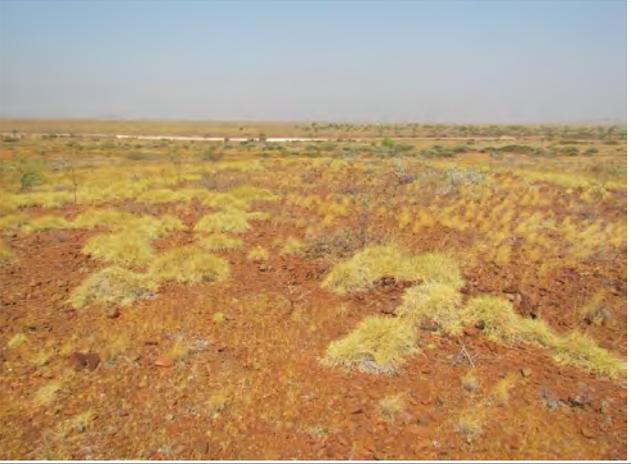
<b>Project area: Roebourne townsite</b>		<b>Releve # : ECO_37_08</b>		<b>Observer/s: JC</b>		
<b>Location</b>	<b>Datum: GDA94</b>				<b>Zone: 50J</b>	
	<b>Coordinates: (UTM)</b>	E 0515060	N 7704676	WPT:	09JC	
<b>Habitat</b>	<b>Landform unit:</b>	Low rocky hill and slopes

<b>Rock type:</b>	Ironstone and basalt				
	<b>Soil:</b>					
	<b>Colour:</b>	Light-Brown				
	<b>Type:</b>	Sandy loam				
	<b>Condition:</b>	Dry				
	<b>Outcropping:</b>	<2%				
<b>Veg Condition:</b>	Degraded					
<b>Disturbance type:</b>	Weeds, Tracks, Rubbish					
<b>Age since fire (yrs):</b>	5 + yrs					
<b>Bare Soil (%): 60</b>		<b>Leaf litter (%): +</b>		<b>Logs (%): +</b>		
<b>Cover (%):</b>		Overstorey:	Midstorey: 5	Understorey: 40		
<b>Vegetation description:</b>						
<i>Acacia pyrifolia</i> , <i>Senna glutinosa</i> subsp. <i>pruinosa</i> and <i>Acacia bivenosa</i> scattered shrubs over <i>Triodia wiseana</i> open hummock

grassland over <i>Aristida contorta</i> tussock grassland

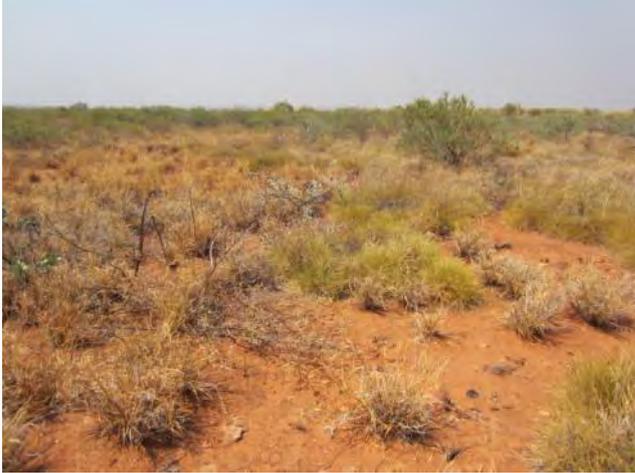
1. Open mixed Acacia shrubland plains

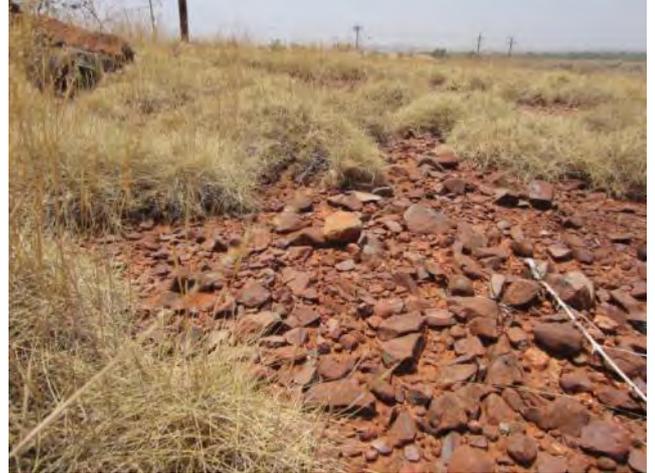
2. Stony low hills, rises and associated rocky gullies.

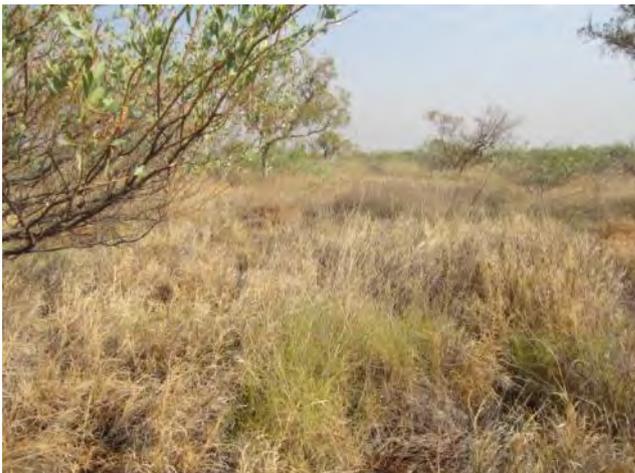
3. Alluvial sand plains associated with creeks

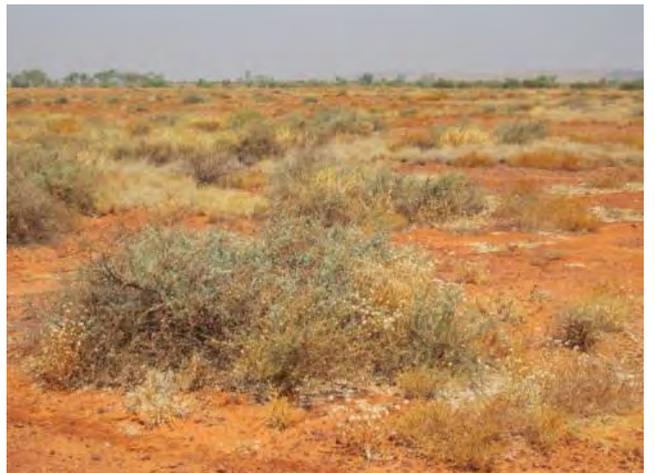
4. Open chenopod clay pans
