# **City of Karratha**

## **Dampier Stormwater Management Study**

### **Report**

June 2015

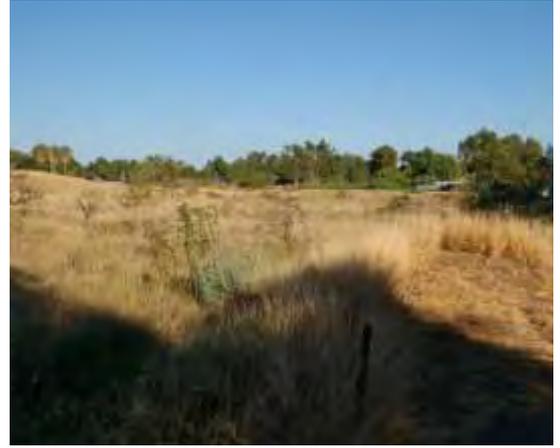
As the study area is built on a rocky plain, the infrastructure is built on fill rather than constructing roads and underground services through the rocky terrain. The houses and their servicing roads are located on fill that varies up to about 1 to 2 meters above the natural terrain (Photo 1).

**Photo 1 Typical fill of house pads**

This photo also shows the original drainage flow path (GHD, 2014)

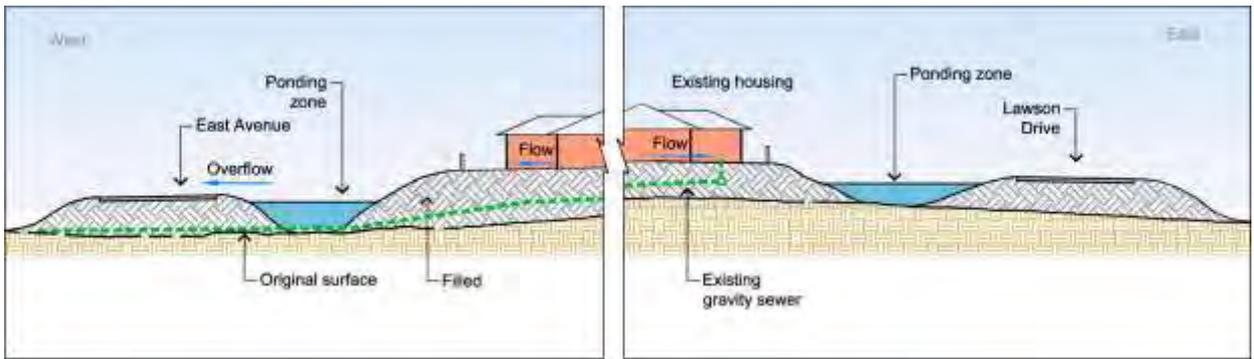
**Figure 4 Typical cross-section of original drainage reserve (east-west)**

Lawson Drive and East Avenue currently create a barrier which ponds water in the drainage reserve upstream of the roads (Figure 4), especially in locations where there are limited or no culverts or during significant events such as a cyclone. It is not clear that the original roads

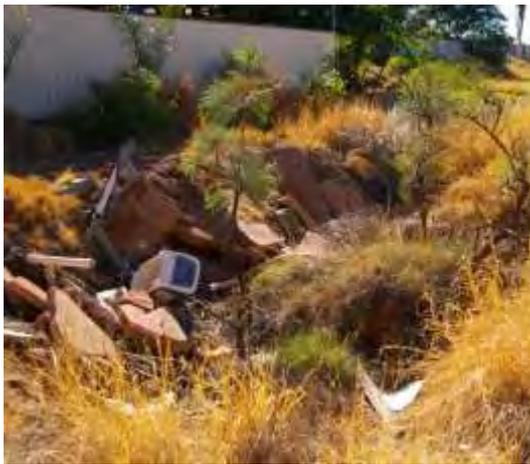
It was found that much of the original drainage reserves have been impacted with uncontrolled fill, typically placed by past and present landholders connecting a rear access to their properties. Photo 3 is typical of the problem where the entire drainage reserve has been infilled in Wilkie Crescent.

**Photo 3 Uncontrolled infill of drainage reserve**

Wilkie Crescent blocking flow path (GHD, 2014)

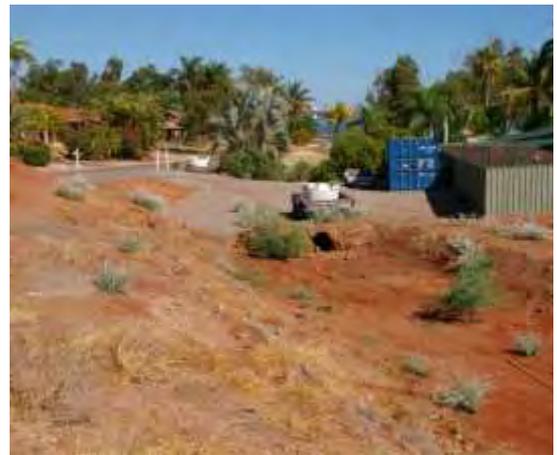
- Extending gardens and their boundaries into the drainage reserve (Photo 4);
- Dumping of materials in the reserve;
- Creation of shortcut roads at the end of cul-de-sacs; and
- Filling of defined flow paths with non-engineered materials to create rear access and or hardstand areas.

**Photo 4 Fencing off of drainage reserve and encroachment**

Typical across Dampier (GHD, 2014)

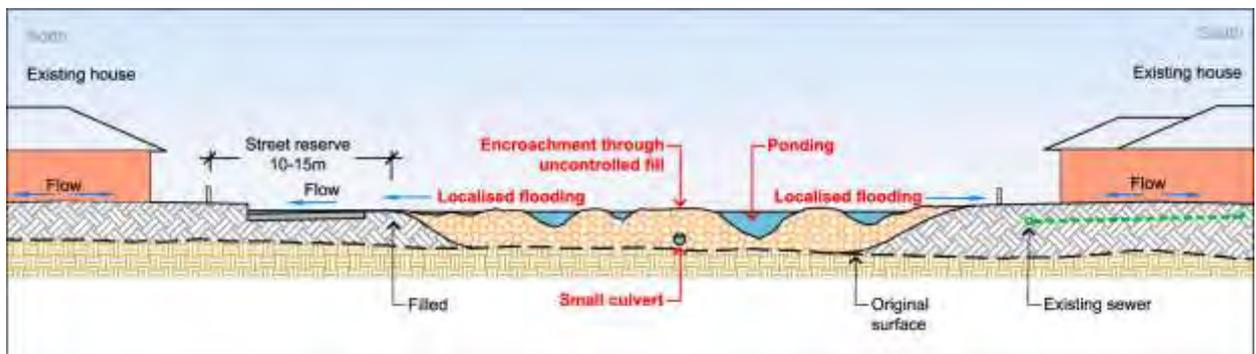
**Figure 5 Typical cross-section of encroachment of drains**

Figure 5 shows a typical detail in a north/south direction of how this encroachment has blocked or reduced the flow paths ability to remove stormwater from the study area. Excessive ponding in low lying and areas where encroachment has partially or completed blocked the drainage path has resulted in flooding shown in the photos taken during the 2006 study (Photo 5).

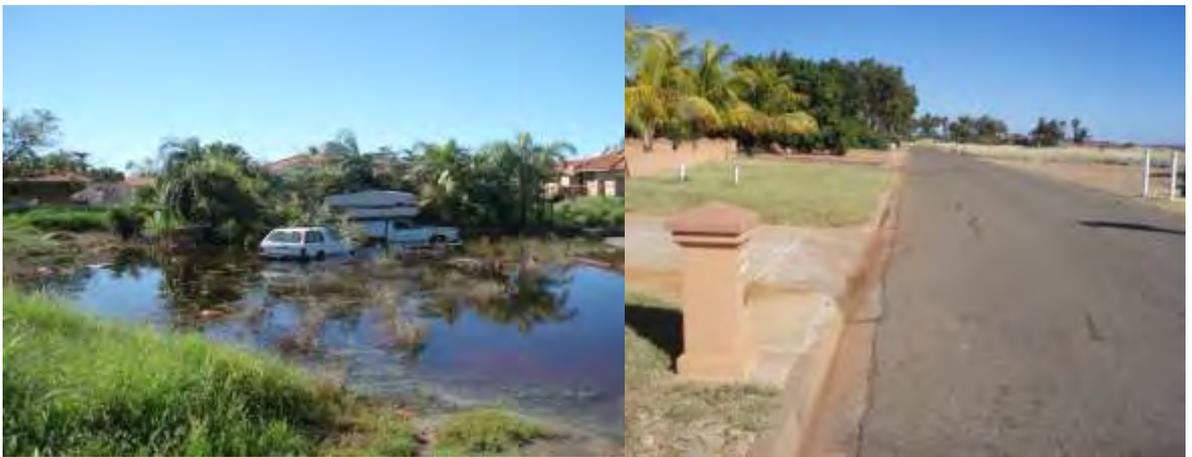
**Photo 5 Pounded area as a result of encroachment**

Pingandy Crescent (RTIO, 2006)

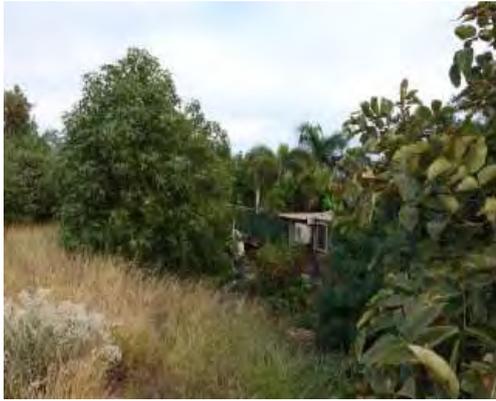
**Photo 7 Dense vegetation growth**

Wilkie Crescent blocking flow path (GHD, 2014)

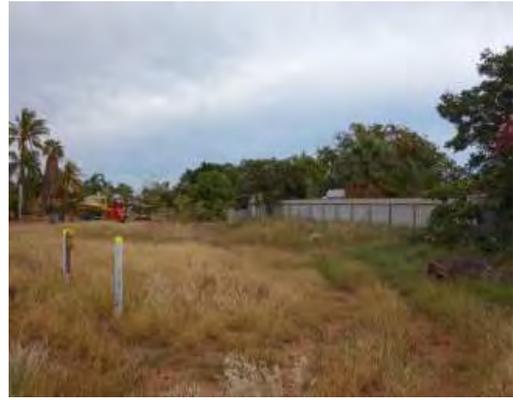
**Photo 8 Removal of sea container**

Refer Photo 4. Gregory Crescent Dampier (GHD, 2014)

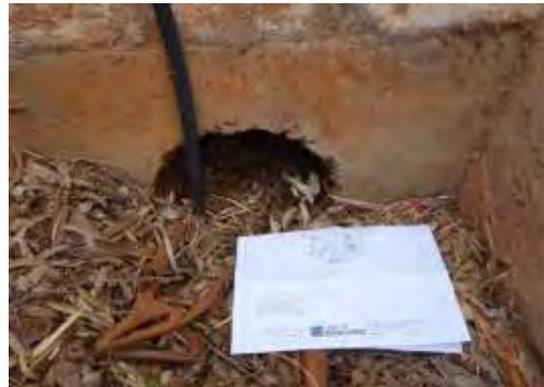
**Photo 10 Blocked culvert**

Wooramel Crescent (GHD, 2014)

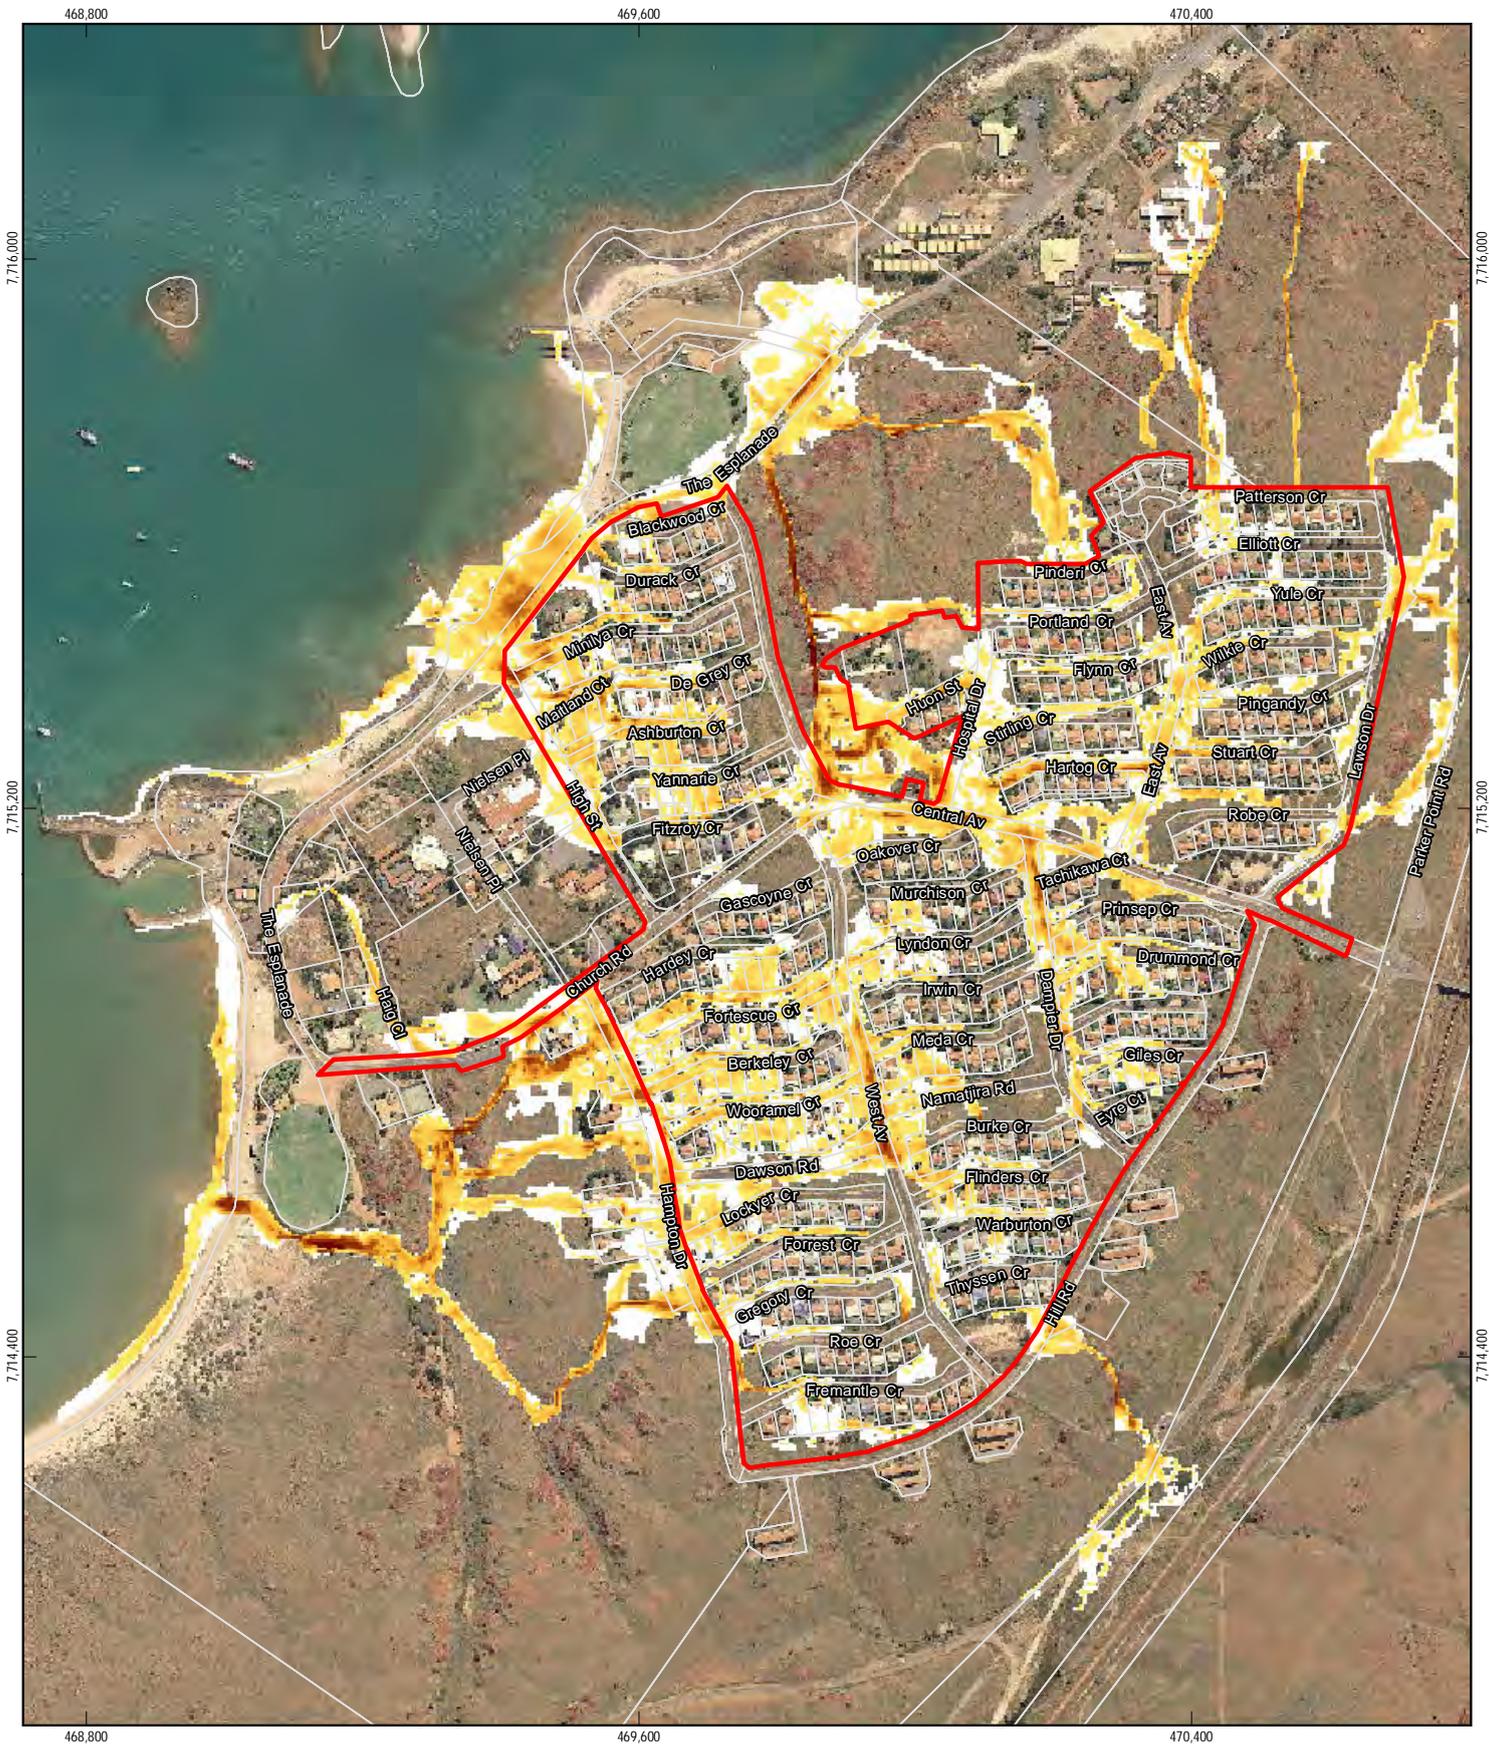
**Figure 11**

The 5 year and 100 year ARI results for the existing scenario are shown in Figure 9 and Figure 10 respectively. Flow velocity for the existing scenario for both the 5 and 100 year ARI events is shown in Figure 11 and Figure 12.

Locations of high velocity as shown in Figure 11 and Figure 12 as modelled for the existing scenario should be used as a reference to determine the potential needs for rock protection following drain remediation. Rock protection should be specified according the velocity exceeded. Open drain junctions and bends greater than 22.5° or locations of high turbulence such as culvert inlet or outlets should also provide an allowance for rock protection to minimise the impact of erosion.

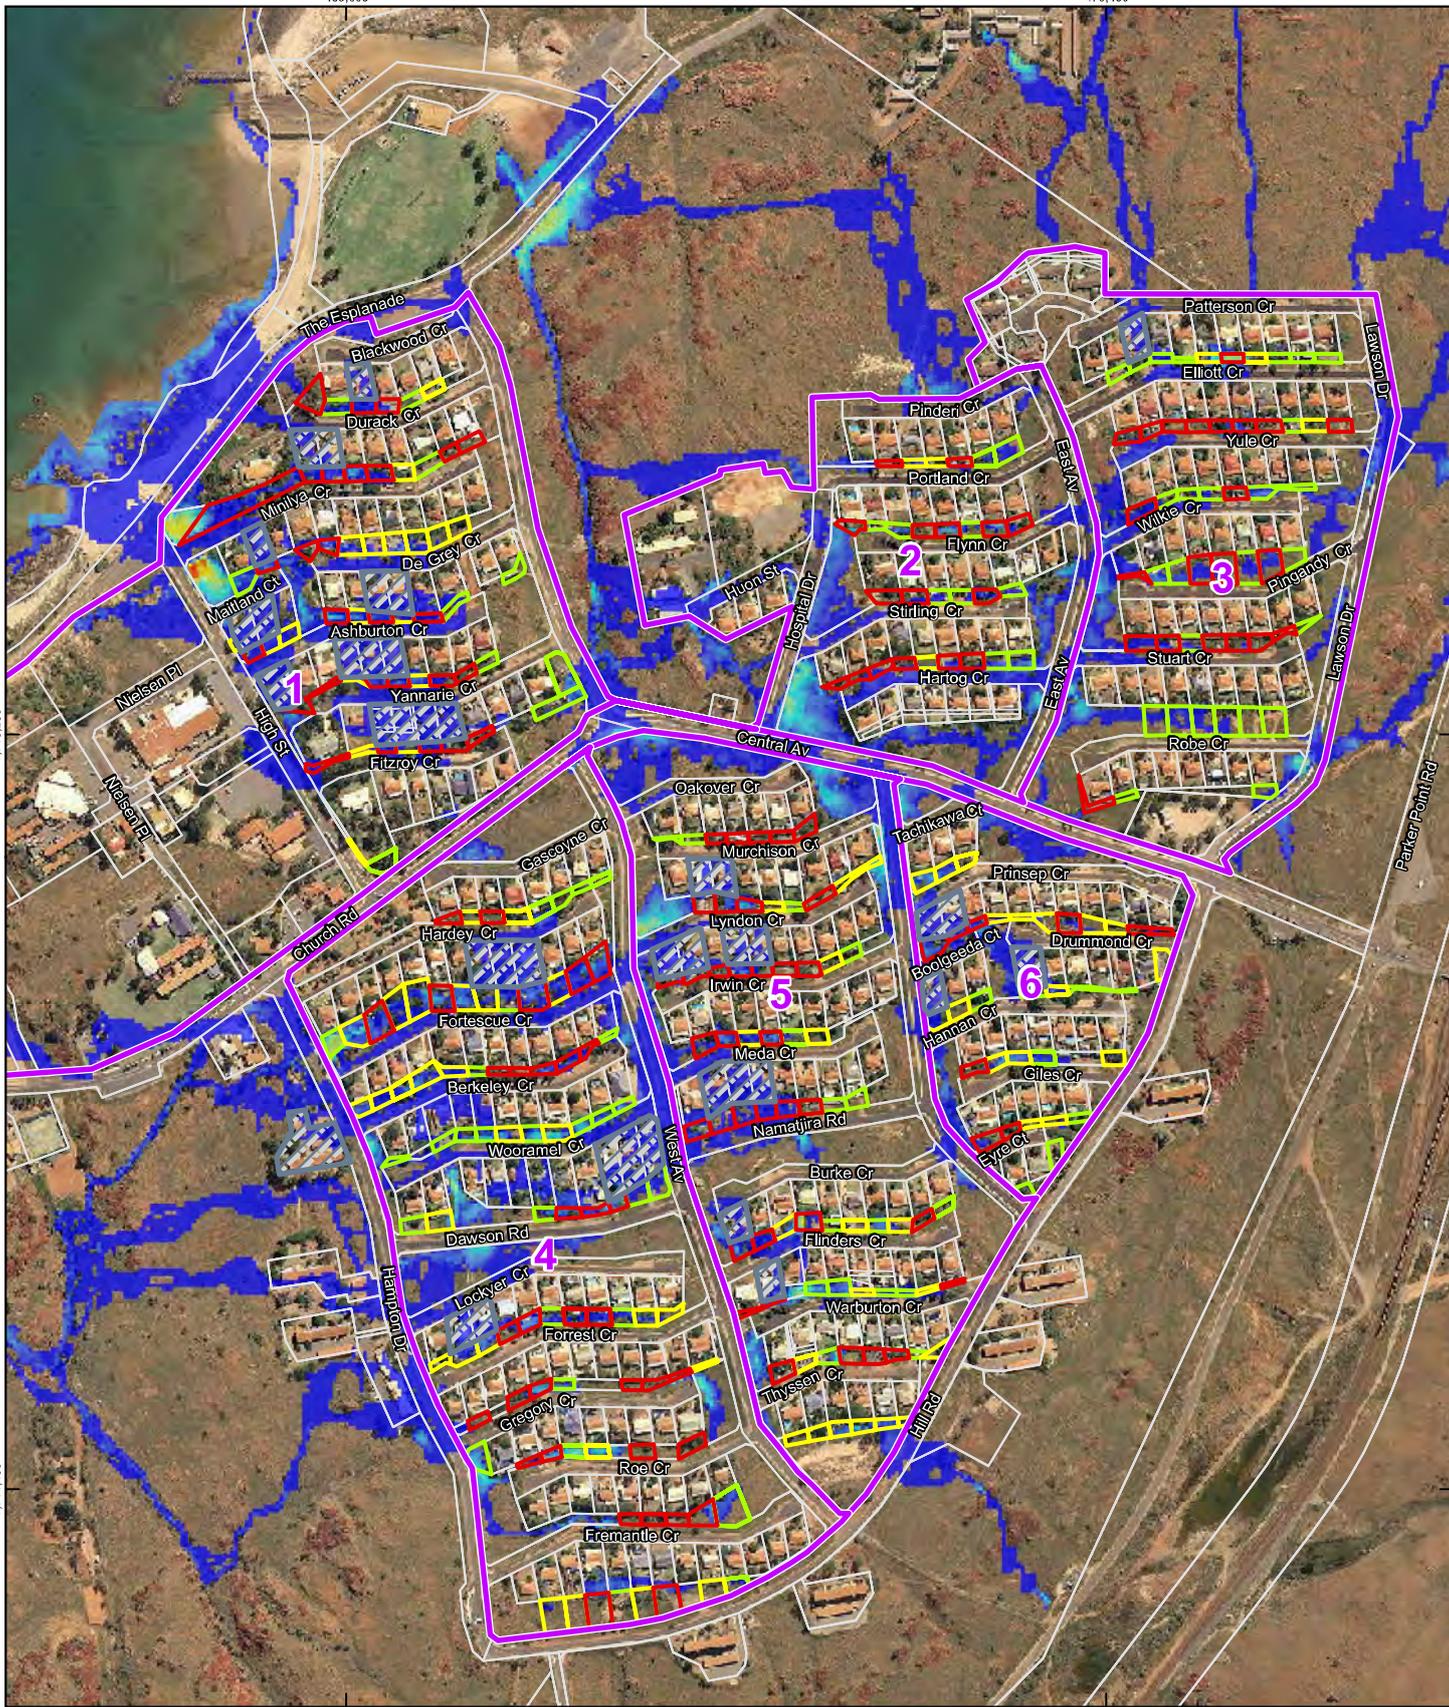
Lots shown within Figure 13 present an elevated flood risk during a 5 year ARI event and correspond to high or medium impact drainage encroachment with such encroachments considered high priority for remediation.

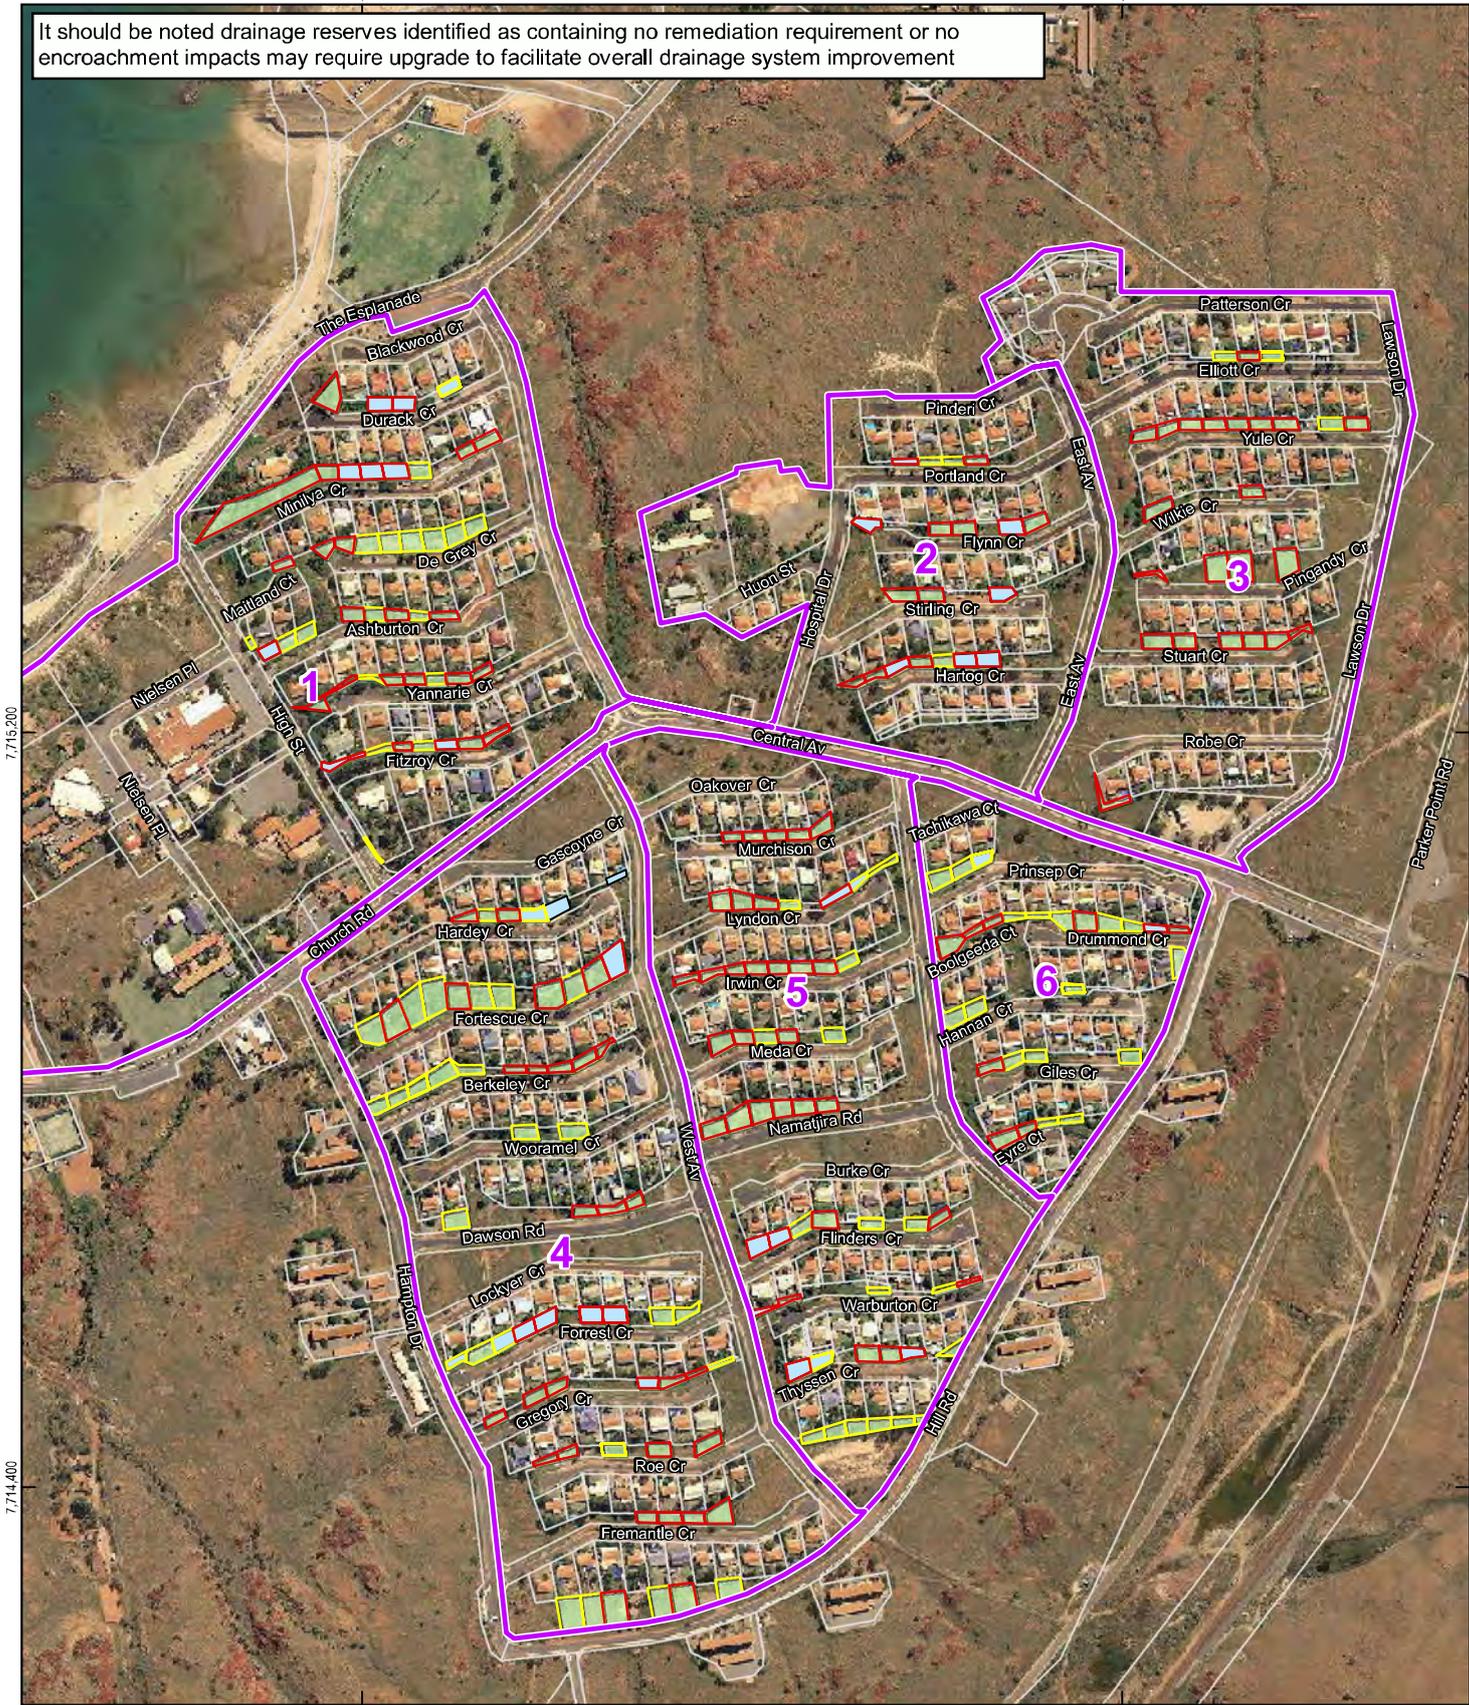
Figure 13

Remediation of the culverts as shown in Figure 14 has been identified as one of two mechanisms listed below:

All other instance of encroachment including lack of drainage infrastructure (no swale), vegetation growth, debris and rubbish were considered maintenance based solutions requiring only reestablishment of the swale.

It should be noted drainage reserves identified as containing no remediation requirement or no encroachment impacts may require upgrade to facilitate overall drainage system improvement as noted in Section 5.2.

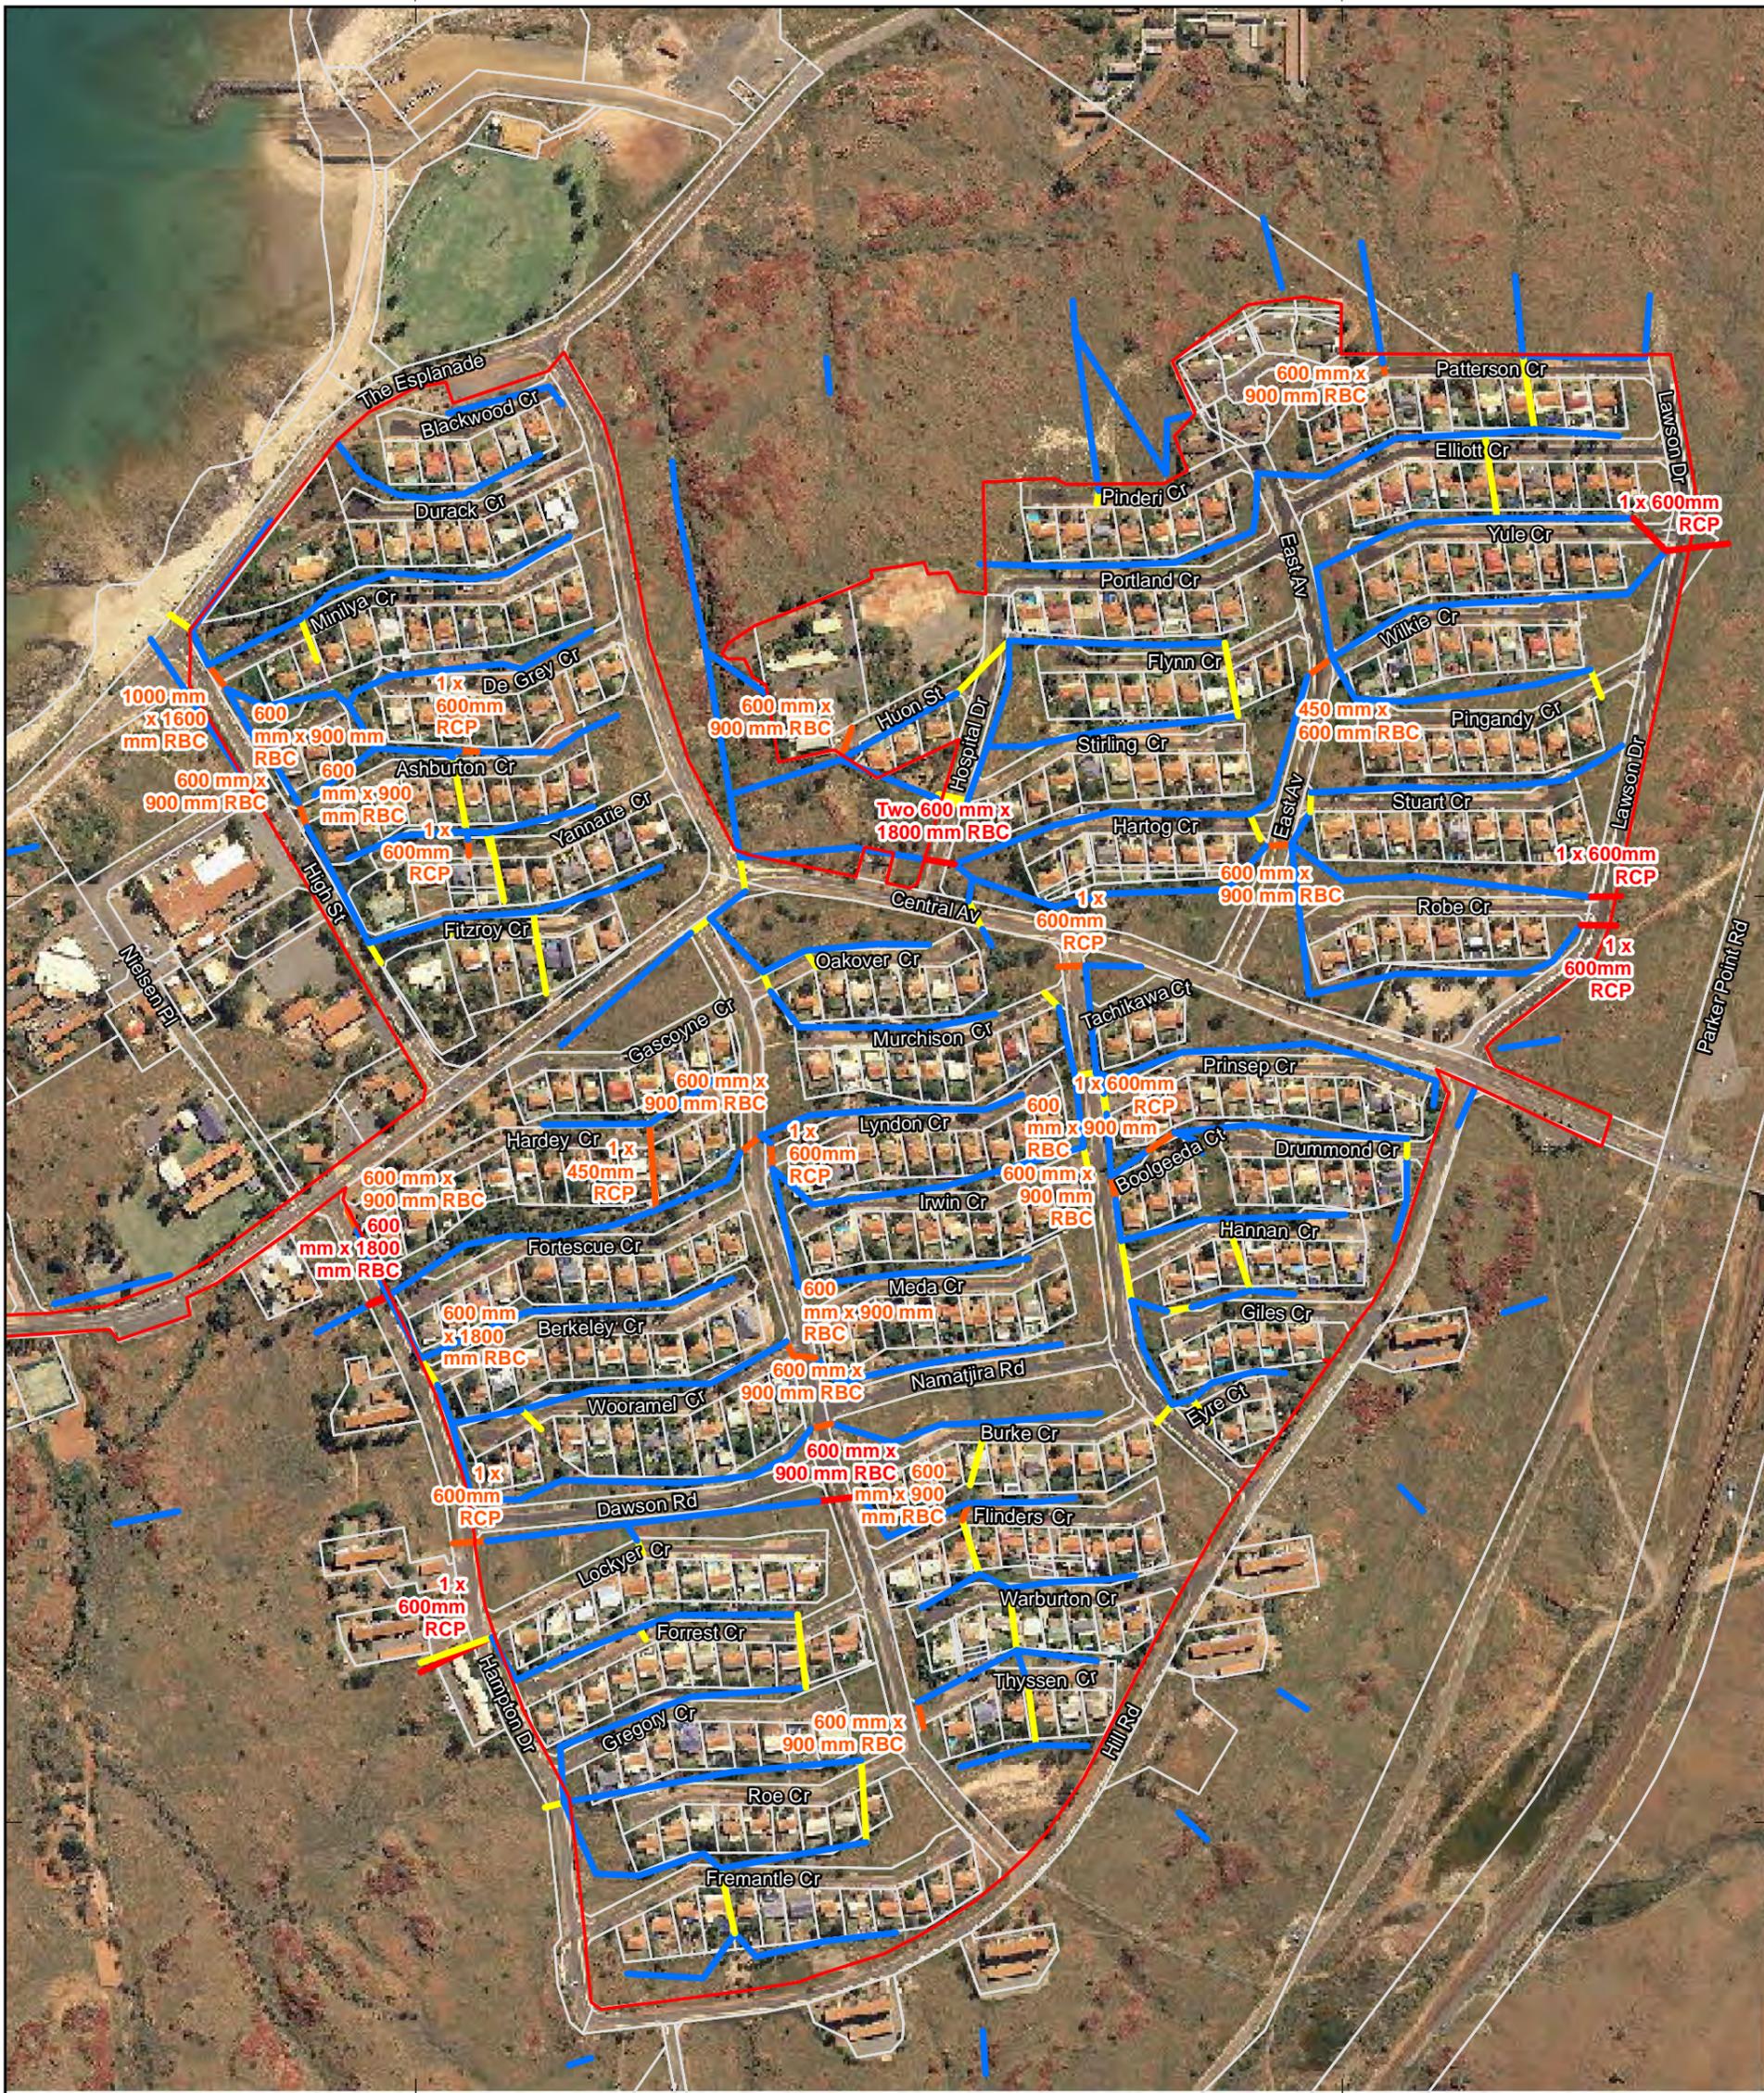
Following open channel remediation, culvert upgrade and specification of new culverts the Dampier townsite flood impact is shown in Figure 17 and Figure 18 for the 5 year ARI and 100 year Ari respectively. The proposed upgrade ensure flood water are contained during the 5 year flood event within the drainage reserves and ensuring during 100 year ARI event water remains within the drainage and road reserves with limited to no impact on property.

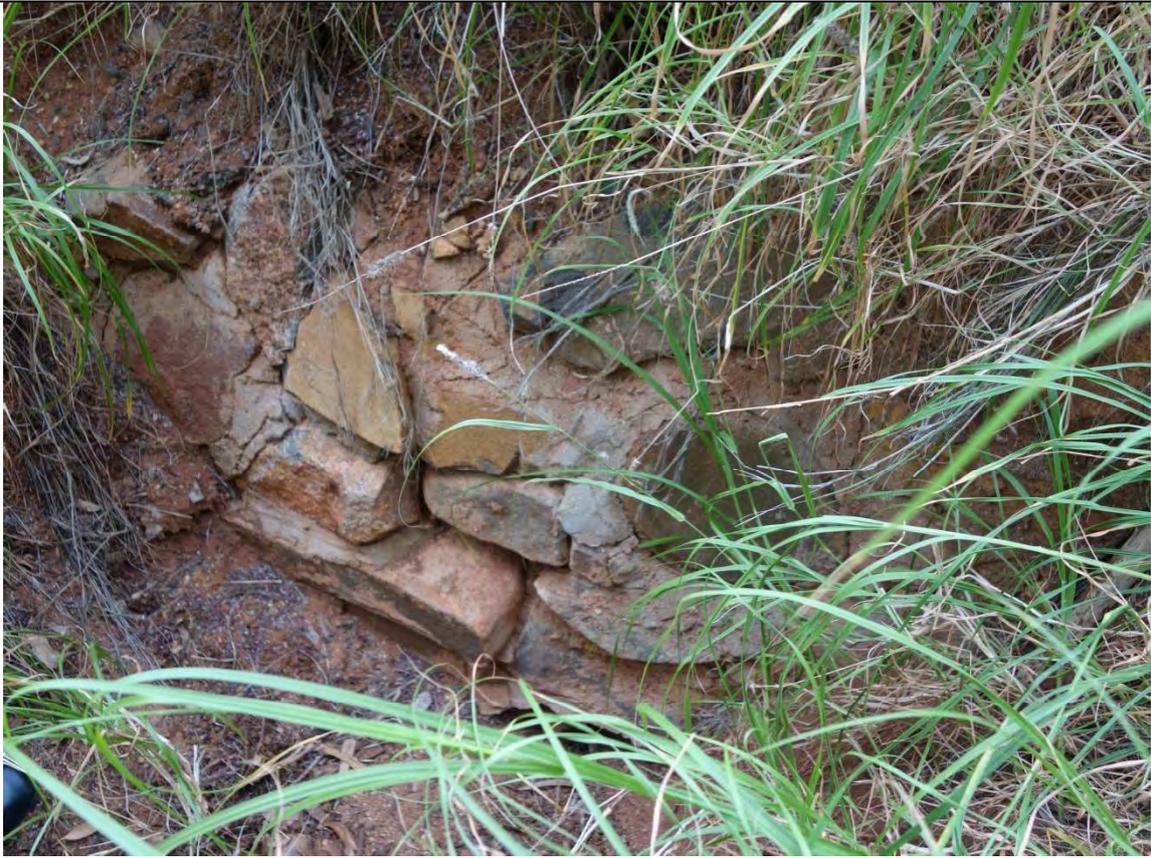
Photo ref. DSC04525

Lot 15 Durack Crescent Culvert

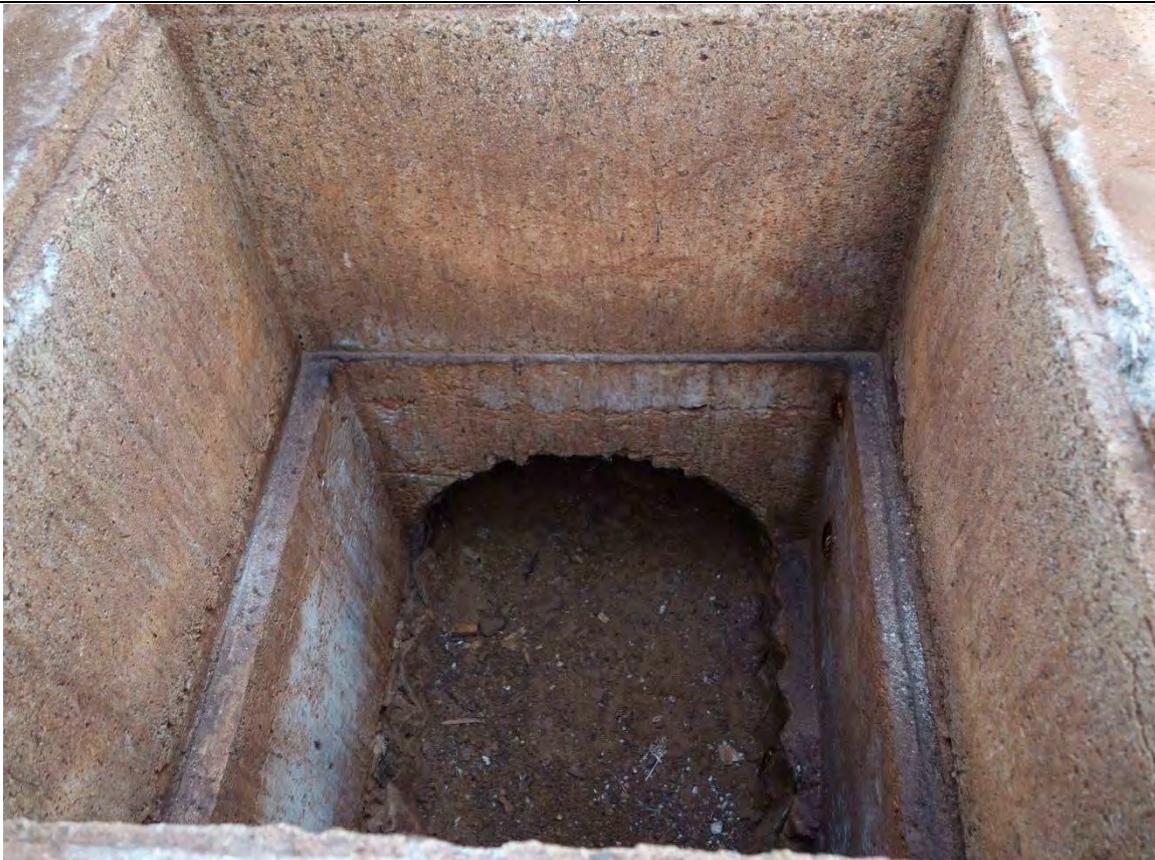
Photo ref. DSC04529

Lot 15 Durack Crescent

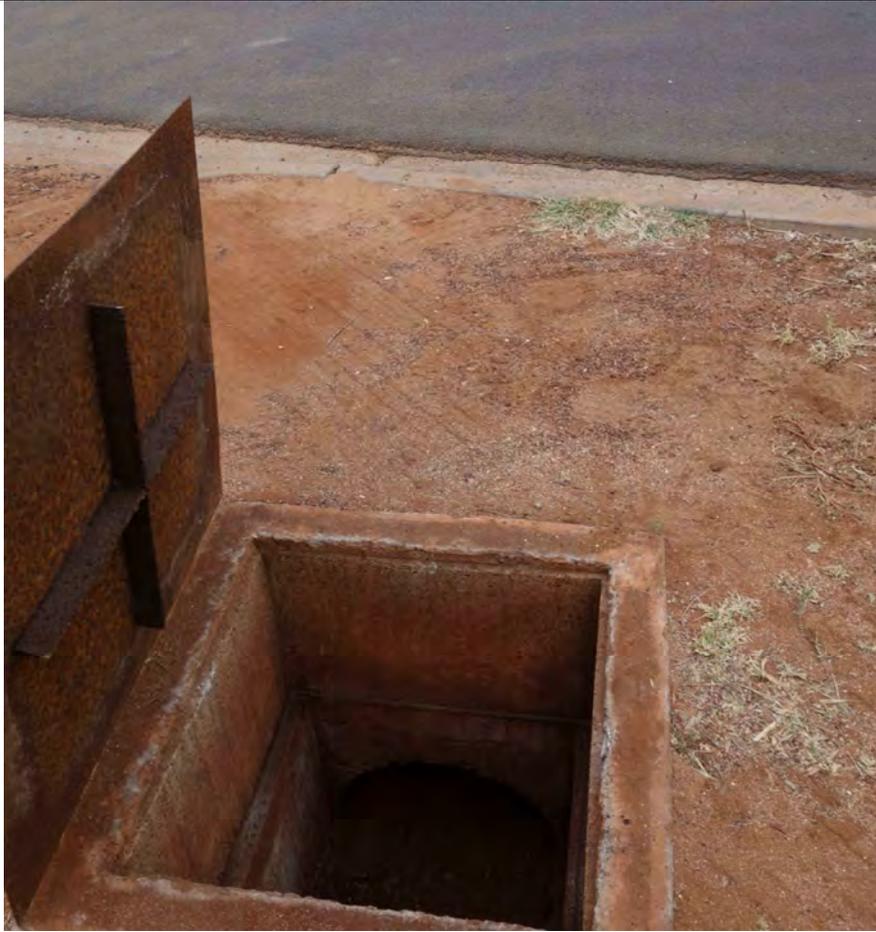
Photo ref. DSC04531

Lot 15 Durack Crescent Culvert
