Place No. 38 Nicol Goldfield

Ruined structures at Nicol Goldfield

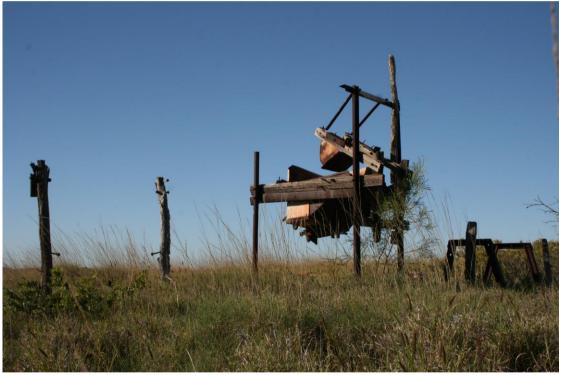
The workings consisted of shallow pits in auriferous quartz veins. The principal mine is approximately 20 m deep and is an open cut mine. Adjacent to the mine are remains of machinery related to ore crushing.

The remains of machinery associated with ore crushing at Nicol Goldfield 2012
